# LEDBURY TOWN COUNCIL

## LEDBURY Town Council Offices

### Report on the Quinquennial Survey

## Report on the Quinquennial Survey for 2025

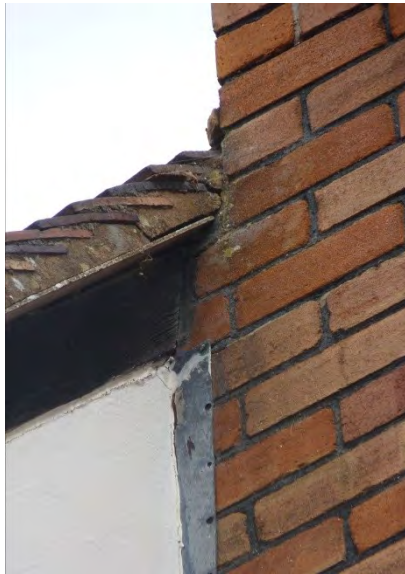
Fig 1.1  
Fractured verge pointing at junction of south east roof with main building. Mastic pointing to lead flashing pulling away.

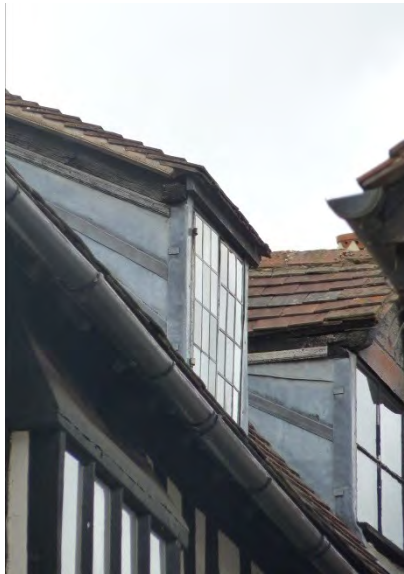
Fig 1.2  
West and central dormers to south elevation.

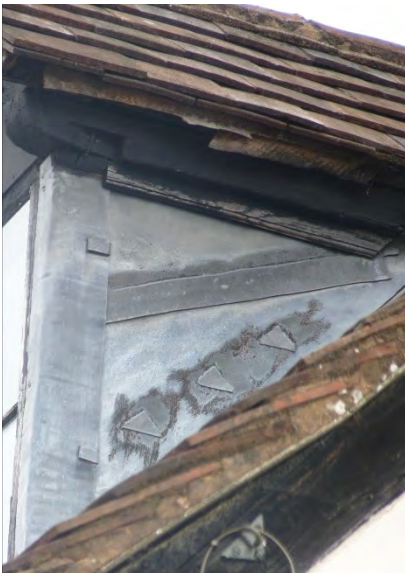
Fig 1.3  
Decaying bituminous felt and window frames to east dormer, south elevation.

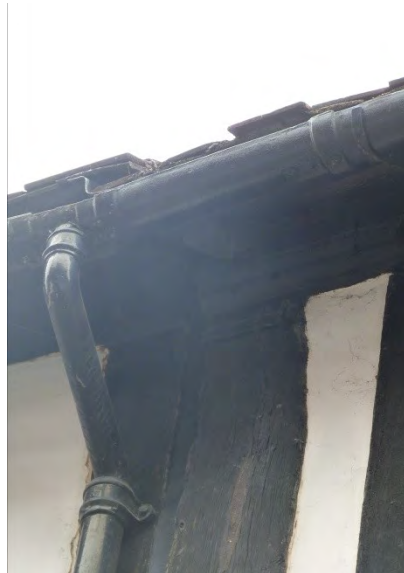
Fig 1.4  
Uneven eaves tiles to south at junction between historic buildings which make up the council offices.

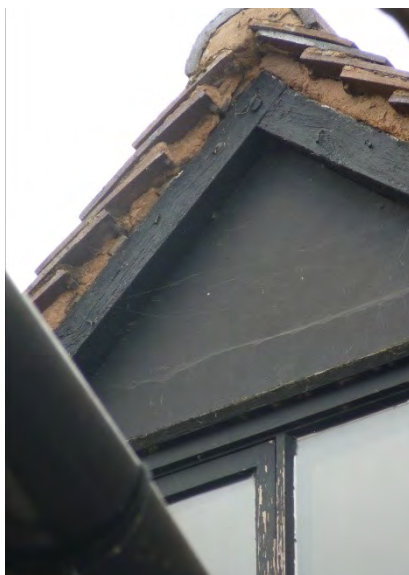
Fig 2.2  
Mortar fillets failing, to north  
elevation dormer. Window joinery  
in need of overhaul and  
re-decoration.

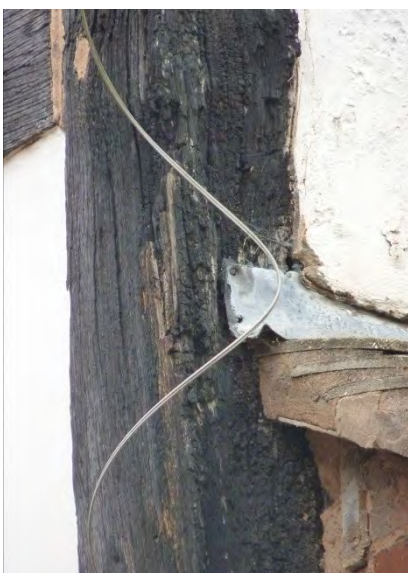
Fig 2.3  
Gaps where rainwater enters at  
junction of head of lean-to roof  
with timber frame and render,  
south east corner.

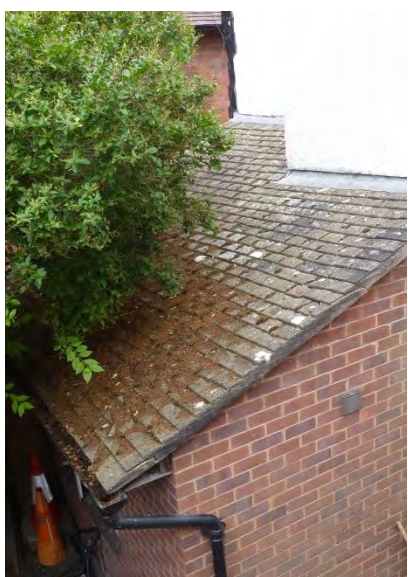
Fig 2.5  
East end roof overwhelmed with  
tree branches and leave mould.  
Fractured verge pointing and open  
end to eaves carpentry.

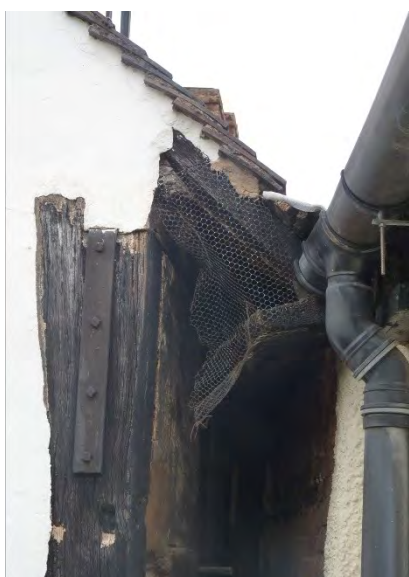
Fig 2.6  
Anti-bird mesh disturbed at  
junction of north east corner of  
main roof with British Legion.

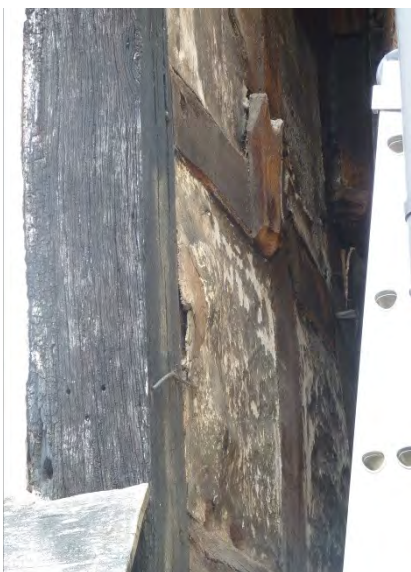
Fig 3.1  
Ancient timber frame and plastered panels at north east corner.

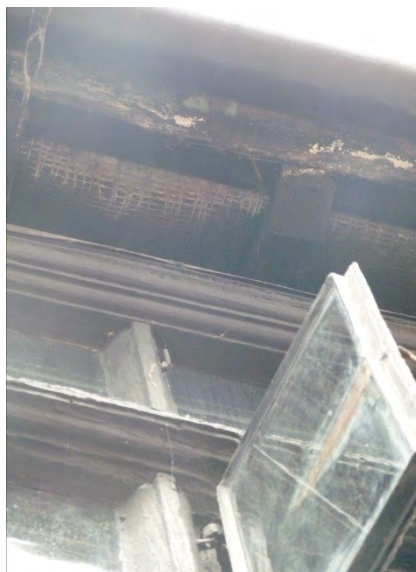
Fig 3.2  
Possibly decaying sarking felt, eaves carpentry behind gutters in need of overhaul to south elevation.

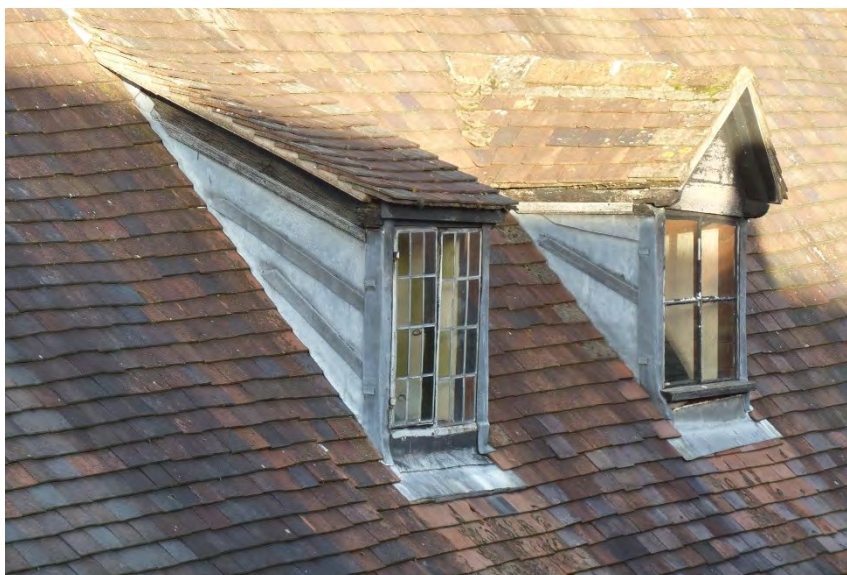
Fig 3.3 and 3.4  
Slipped clay plain tiles with moss build-up, windows and roof carpentry to south dormers in need of overhaul. Slipped apron flashings beneath dormer windows.

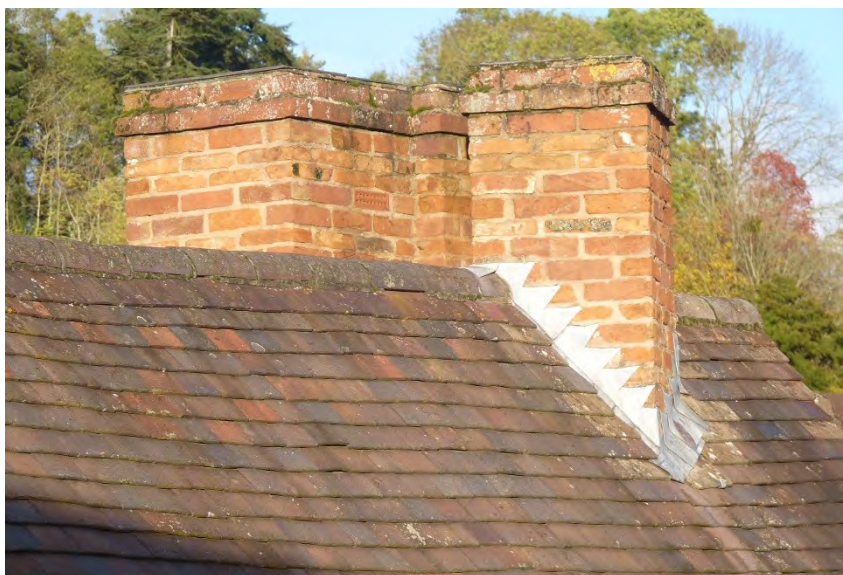
Fig 4.1  
Central chimney stack. Upper brick courses and slate and cement capping saturated. Mortar bedding to ridge tiles loosening.

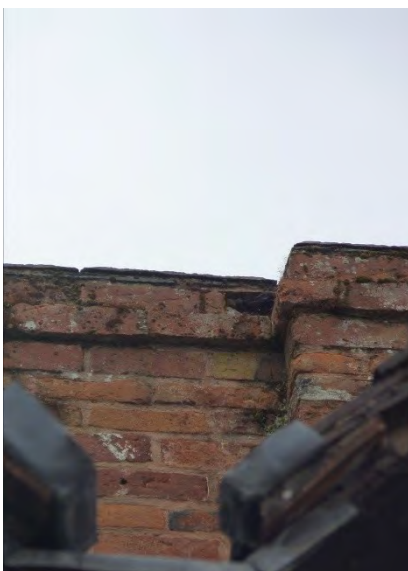
Fig 4.2  
North elevation of central stack. At least one friable brick. Moss grows on joints between slate capping and on brickwork.

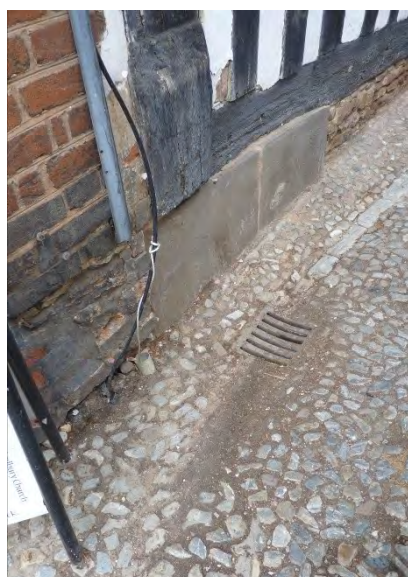
Fig 4.4  
Decaying plaster infill panel, loosened cobblestones at south west corner. Water may run down service ducts.

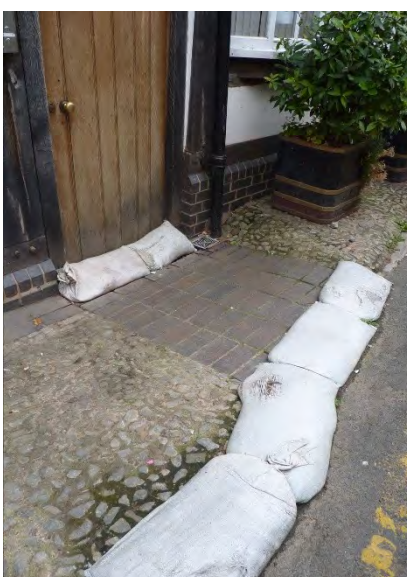
Fig 4.5  
Sand bags needed to reduce water running down road entering the main north door.

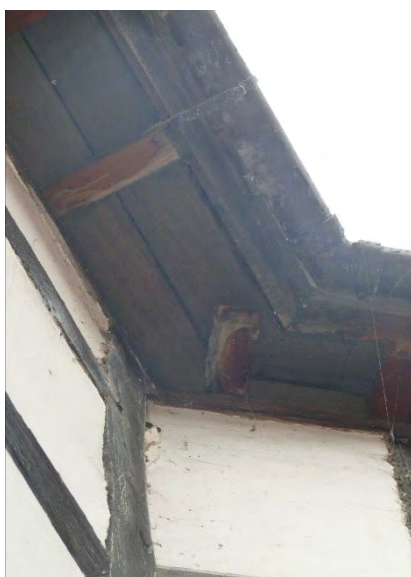
Fig 5.1  
Rainwater staining to rafter ends  
beneath eaves. North west corner.

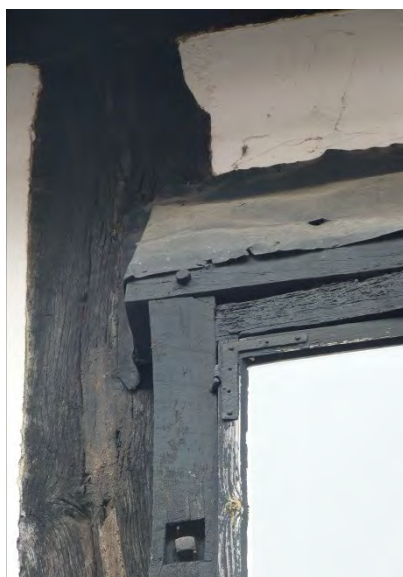
Fig 5.2  
Lifting and damaged leadwork and  
gaps above first floor window frame  
to south elevation.

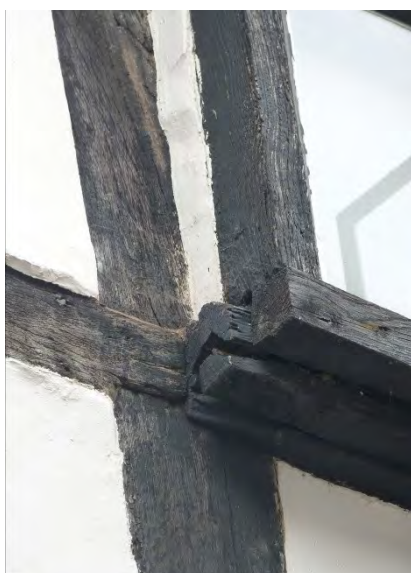
Fig 5.3  
Gaps to timber frame beneath  
window cill, south elevation.

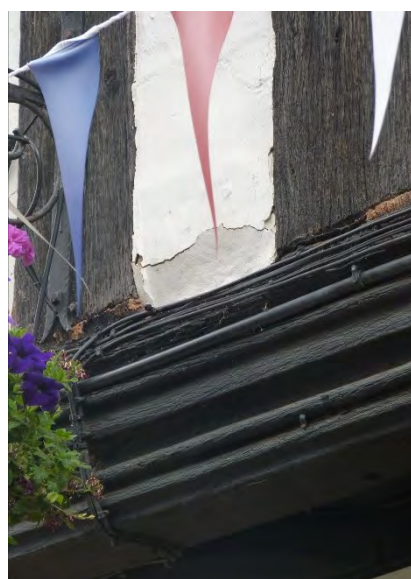
Fig 5.5  
Fracturing to first floor infill panel  
to timber frame.

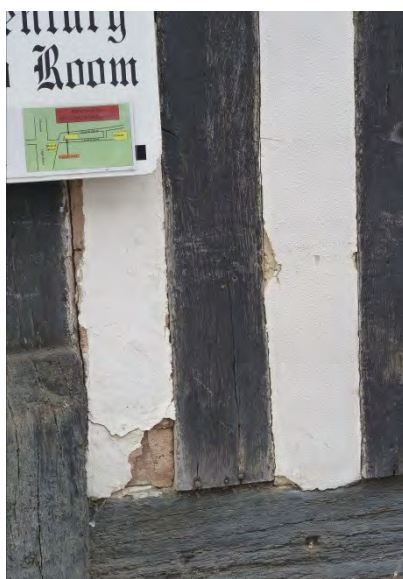
Fig 5.6  
Damaged plaster infill panels at low  
level to south east corner.

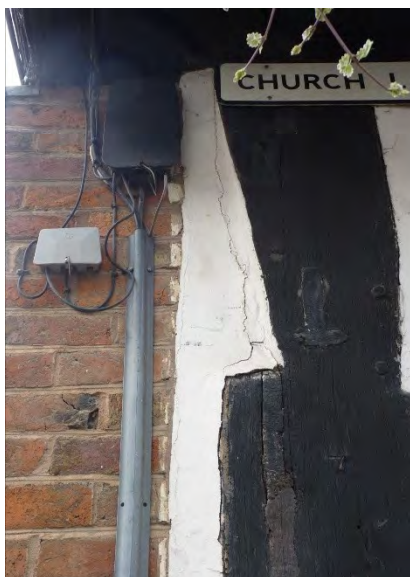
Fig 6.1  
Fractures in infill panels at high level to south west corner. Caulking striking back.

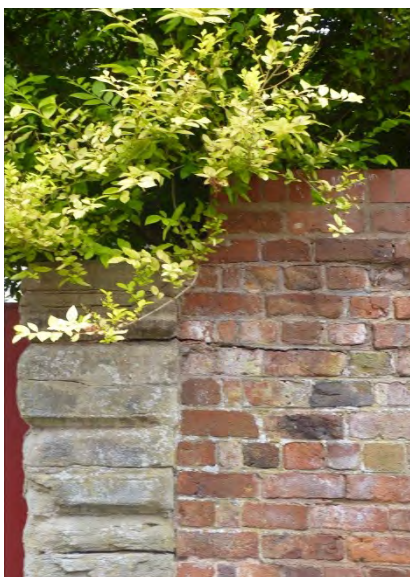
Fig 6.2  
Fractures in yard wall to south east.

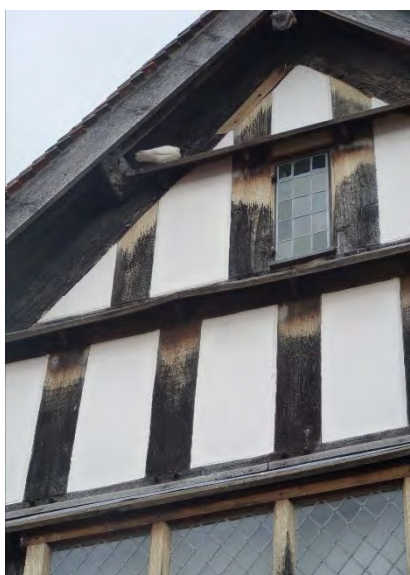
Fig 6.3  
West gable carpentry would benefit from staining. Pigeon roosting on pentice board.

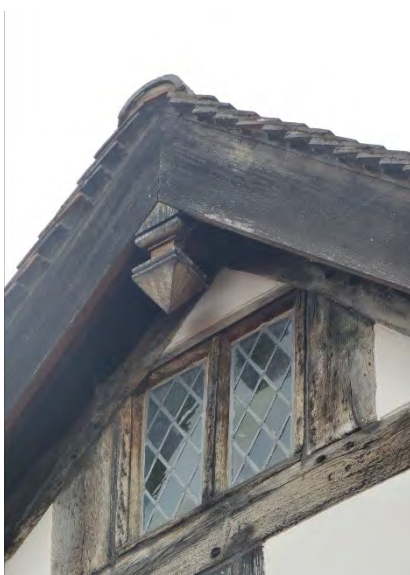
Fig 6.4  
Decaying window frame and oak frame to north gable, open peg holes, all allowing water penetration.

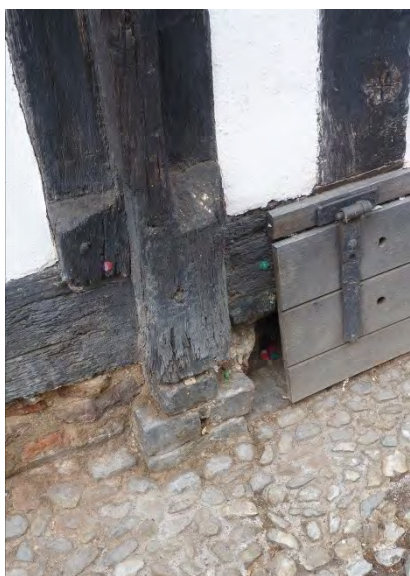
Fig 6.5  
Cellar hatch, loose cobbles and sets, allowing water penetration.

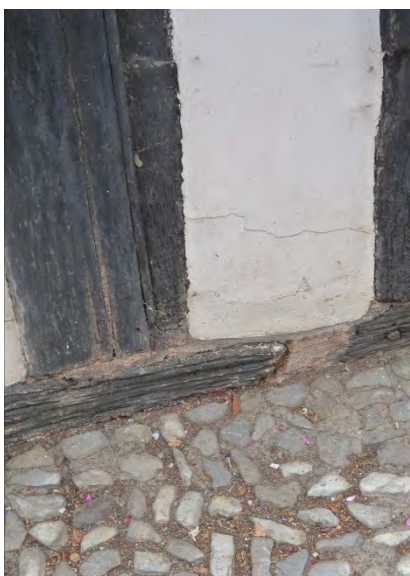
Fig 6.6  
Decaying sole plate and fractured plaster panel.

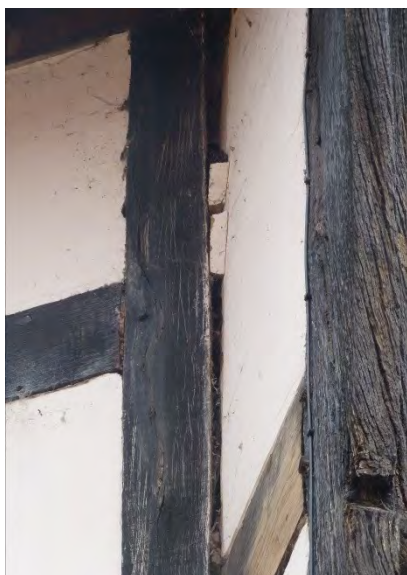
Fig 7.1  
Gaps between frame and infill panels to north west corner.

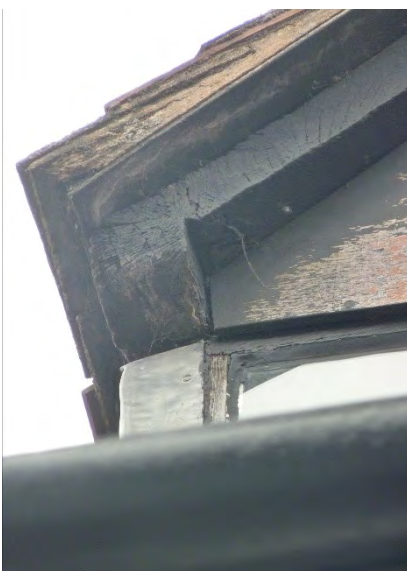
Fig 7.3  
North dormer window frame in poor condition. Gaps allowing water entry around dormer carpentry.

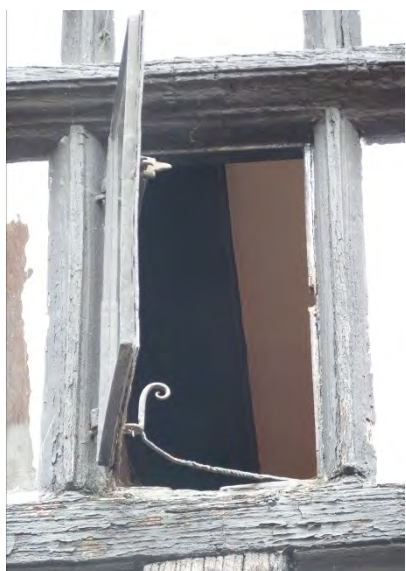
Fig 7.4  
Ancient timber window frame and window in urgent need of overhaul and redecoration.

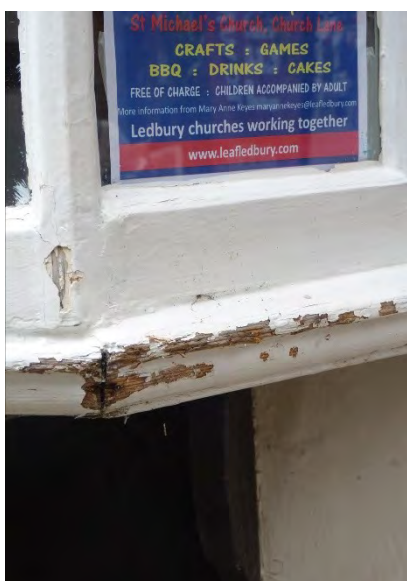
Fig 7.5  
Painted hardwood bay window in need of maintenance.

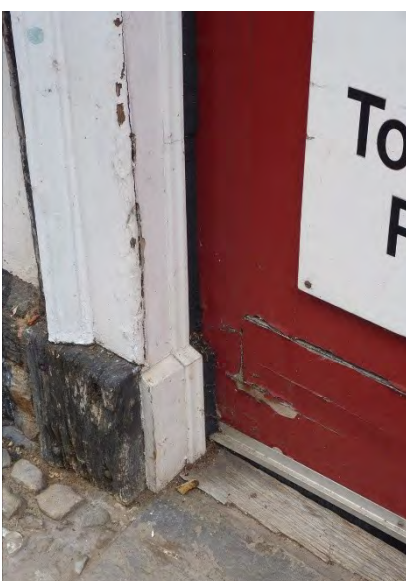
Fig 7.6  
Rear door and frame to Painted Room in need of maintenance.

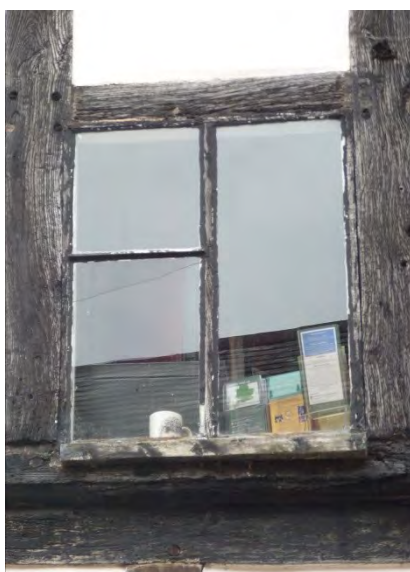
Fig 8.1  
First floor window in poor condition with putty failing.

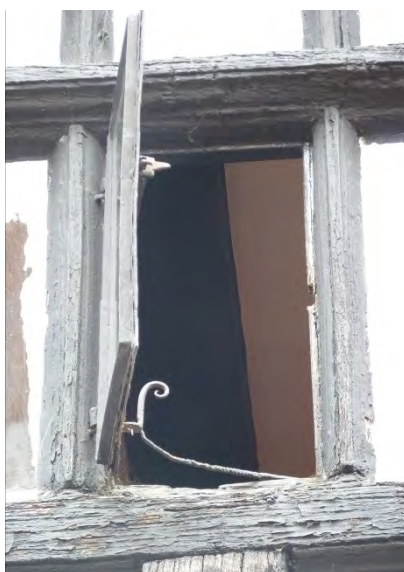
Fig 8.2  
Timber and metal window frames and putty in poor condition.

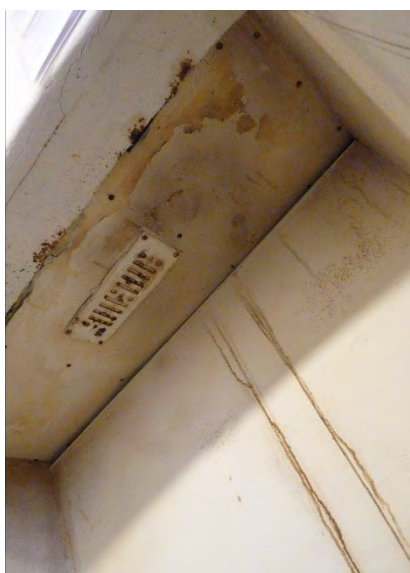
Fig 8.3  
Active leaks to chimney flue in easternmost ground floor office.

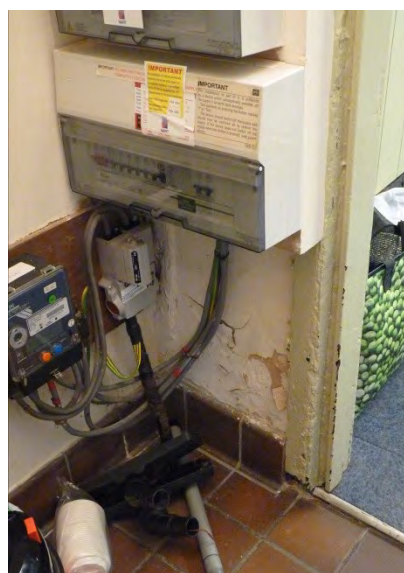
Fig 8.4  
Switchgear fixed to damp internal wall.

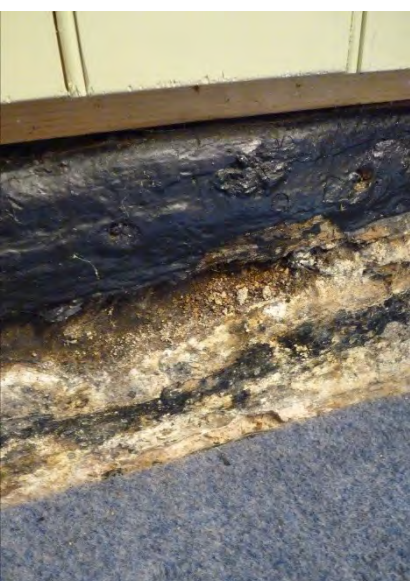
Fig 8.5  
Friable stone plinth beneath gloss painted sole plate to easternmost office.

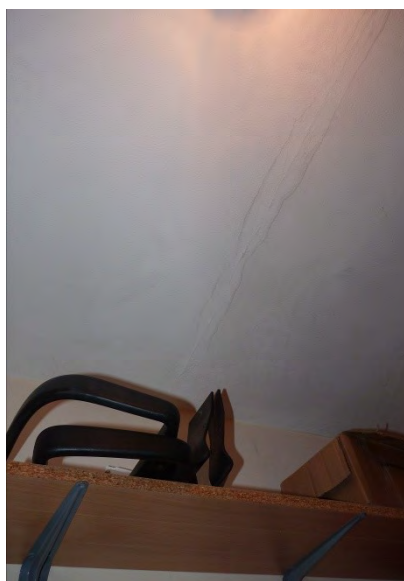
Fig 8.6  
Water staining in ceiling to east lean-to.

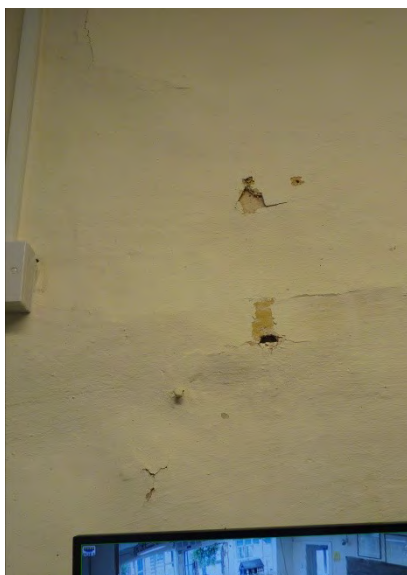
Fig 9.1  
Historic plaster suffering fractures  
and mechanical damage in eastern  
ground floor office.

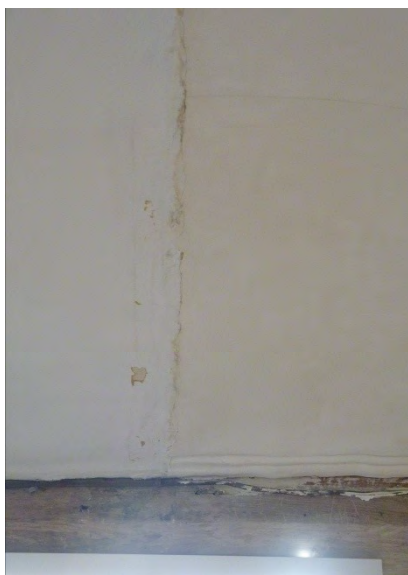
Fig 9.2  
Slight plaster damage at junction of  
modern and historic plaster with  
moulded cornice, above the  
reception desk.

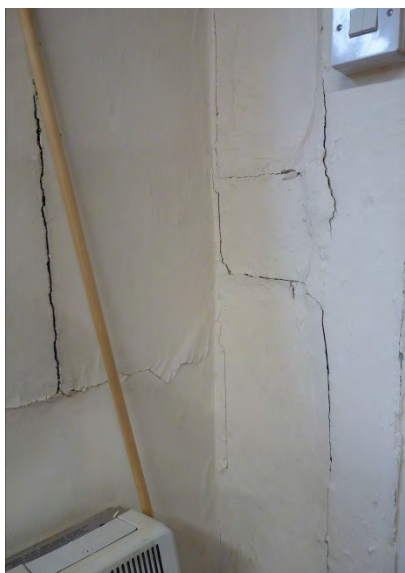
Fig 9.3  
Reopened fractures at south west  
corner of reception.

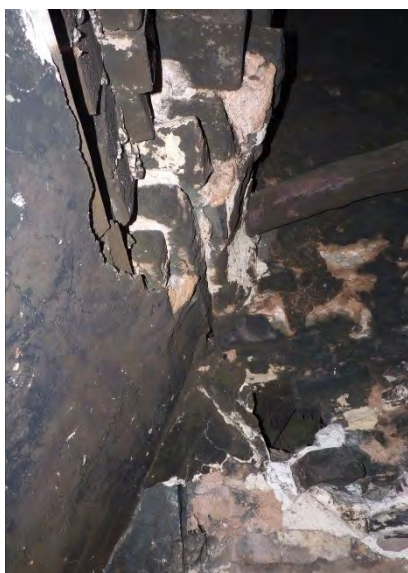
Fig 9.4  
Gathering inside flue to council  
chamber.

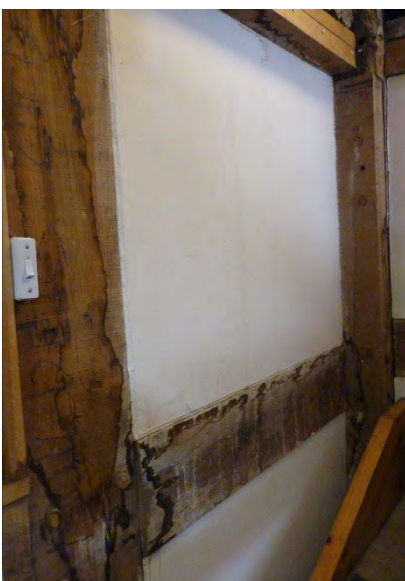
Fig 9.5  
Water staining to modern timber  
frame to Painted Room stairwell.

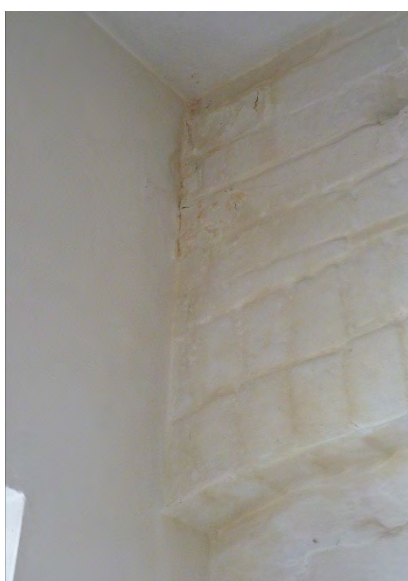
Fig 9.6  
Dampness in brickwork to east  
kitchen wall.

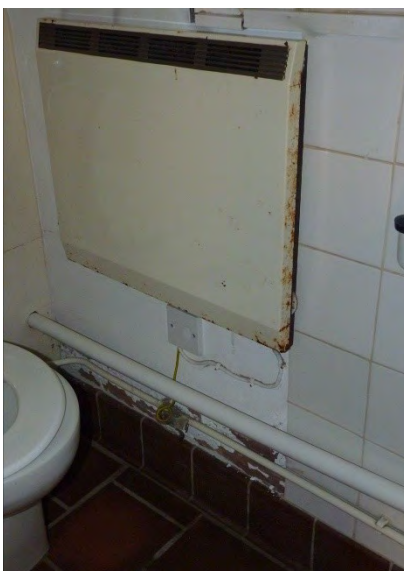
Fig 10.4  
Rusting radiator and dampness in  
male WC.

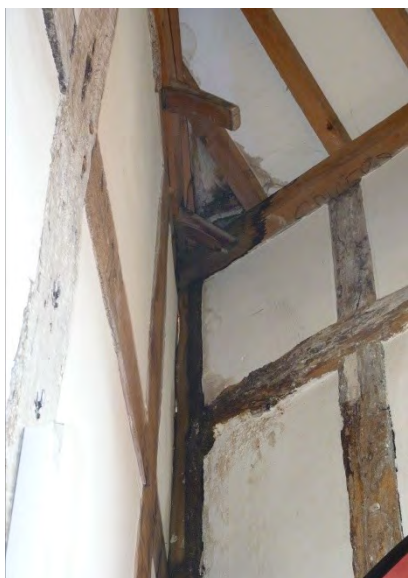
Fig 10.5  
Worsening dampness in ceiling and  
timber frame wall at junction of  
Painted Room stairwell with north  
west corner of main building.

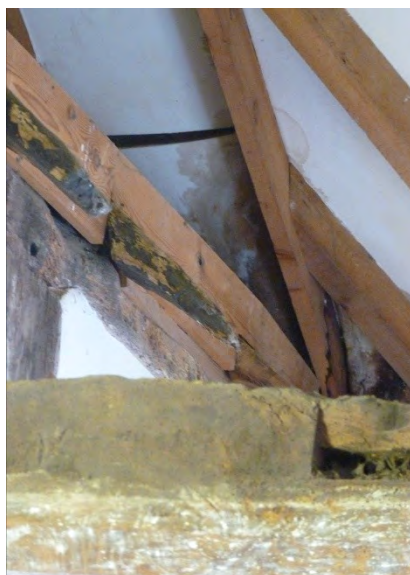
Fig 11.2  
Water penetration at eaves level to  
internal north wall.

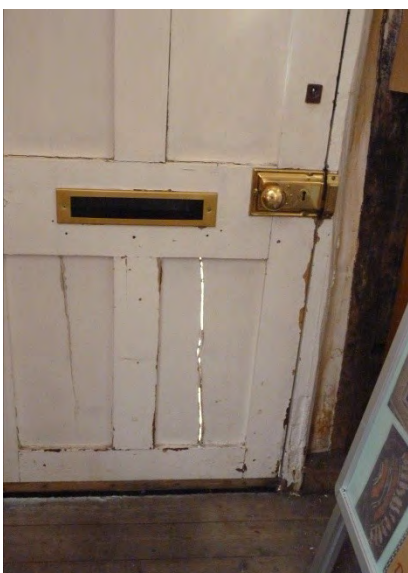
Fig 11.3  
External door to Painted Room  
stairwell in need of repair.

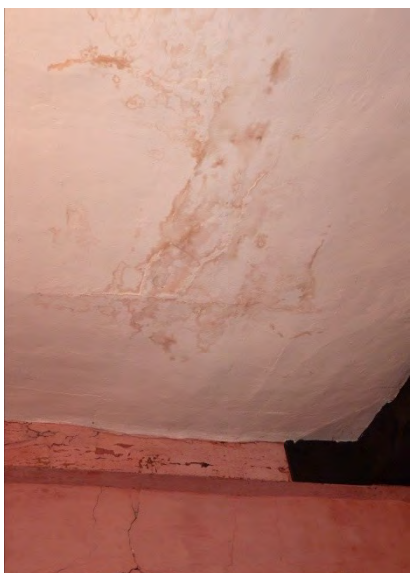
Fig 11.4  
Dampness in ceiling and north wall  
to Pink Room.

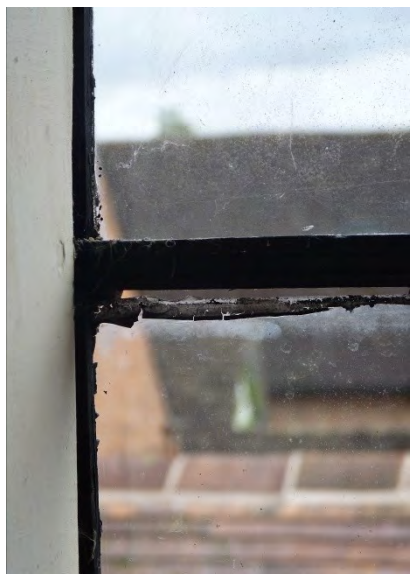
Fig 11.6  
Gaps between glass and frame to  
south attic window.

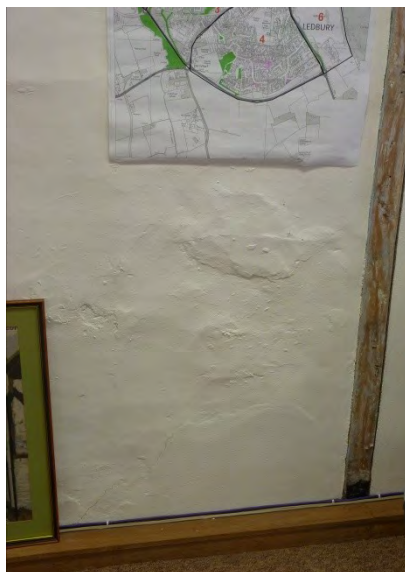
Fig 13.2  
Historic plaster much patched, fracturing and suffering wear and tear.

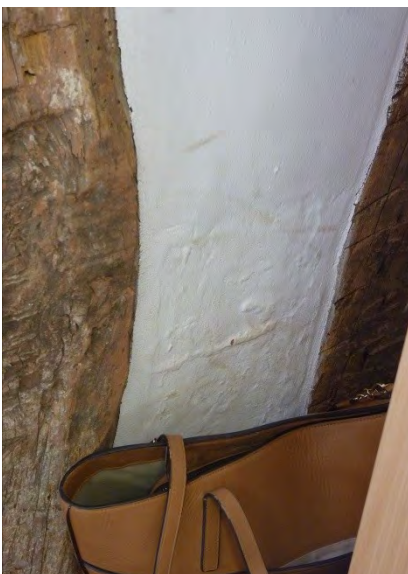
Fig 13.3  
Dampness in south external wall to first floor office.

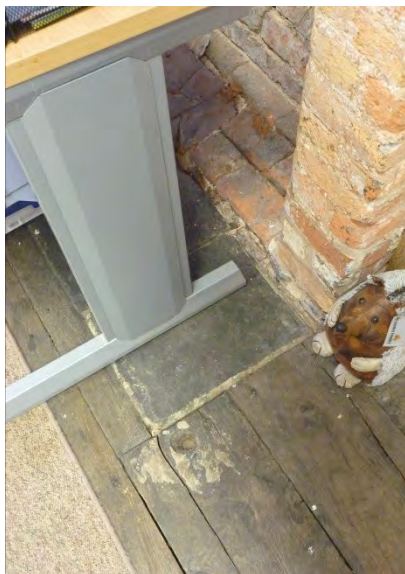
Fig 13.4  
Draughts and brickwork spalls from chimney flue in first floor office.

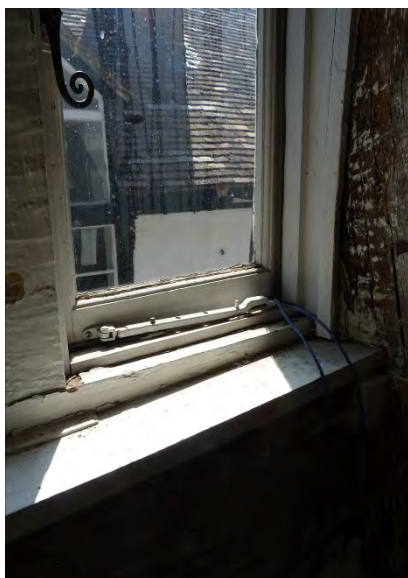
Fig 13.5  
Ill-fitting windows and carpentry in poor condition, to south facing windows.

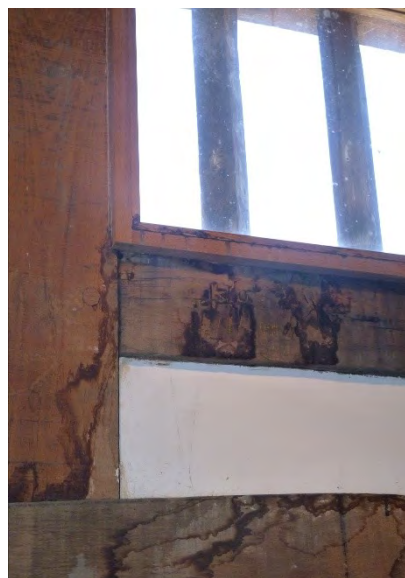
Fig 13.6  
Water penetration beneath attic north window.

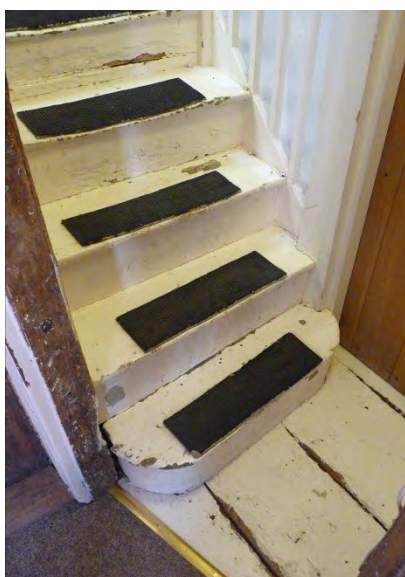
Fig 14.1  
Narrow and steep stair to attic.  
Worn floor boards.

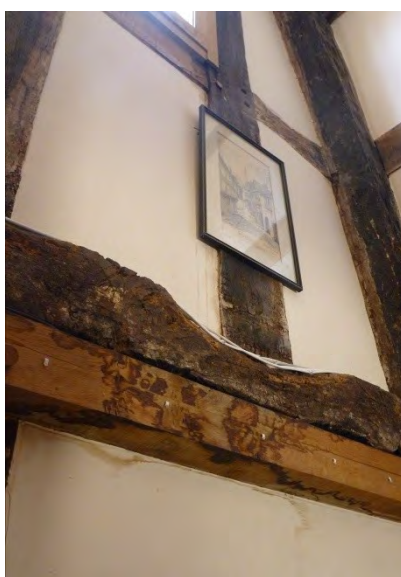
Fig 14.2  
Water penetration at high level  
inside north gable.

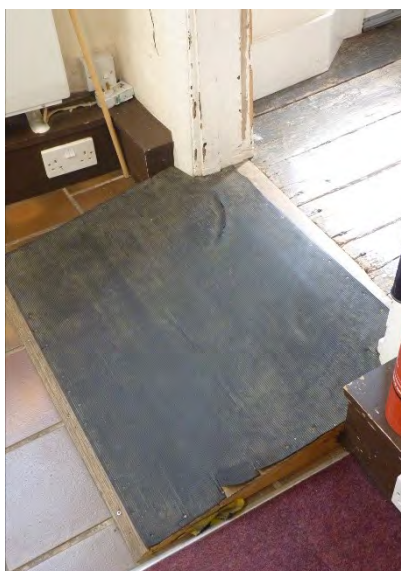
Fig 14.4  
Internal ramp leading to council  
chamber in need of repair.

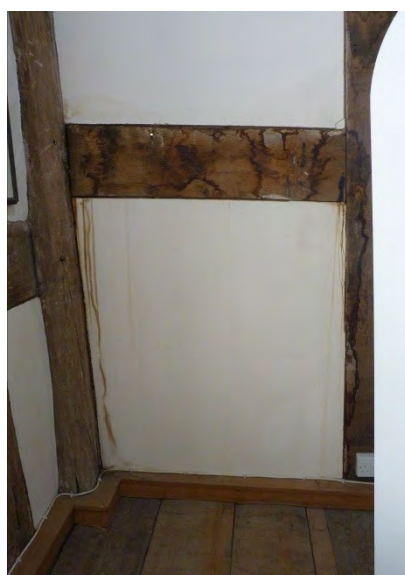
Fig 14.5  
Water penetration to south wall of  
Painted Room.

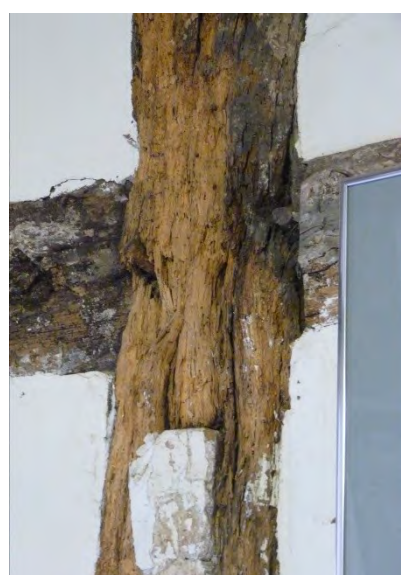
Fig 14.6  
Old decay and wood boring beetle  
attack to timber frame.

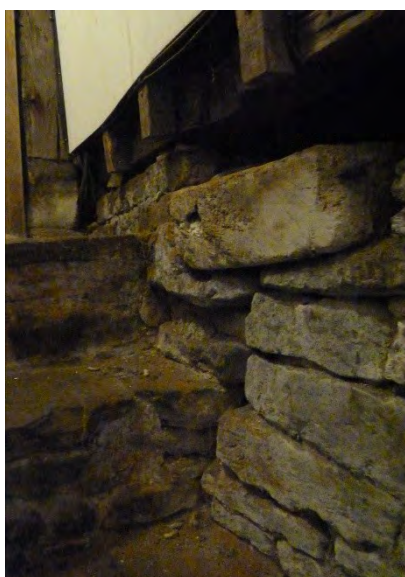
Fig 15.1  
Timber ground floor set on damp,  
loose stone walls to cellar.

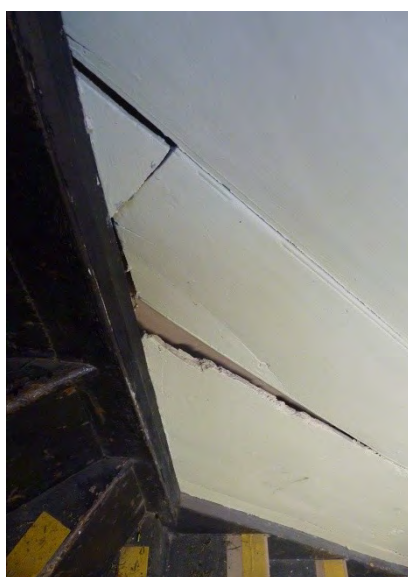
Fig 15.2  
Dislodged linings adjacent to first  
floor staircase.

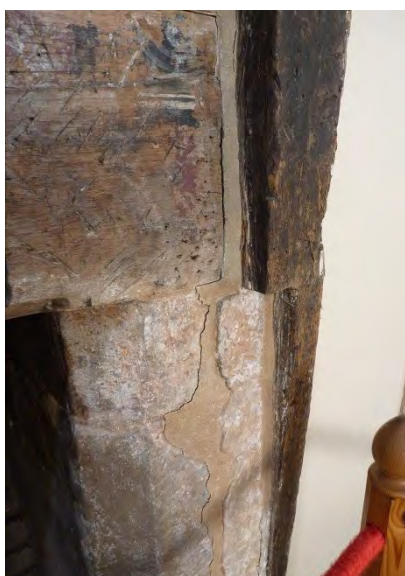
Fig 15.5  
Hairline cracks in repairs to Painted  
Room plasterwork.

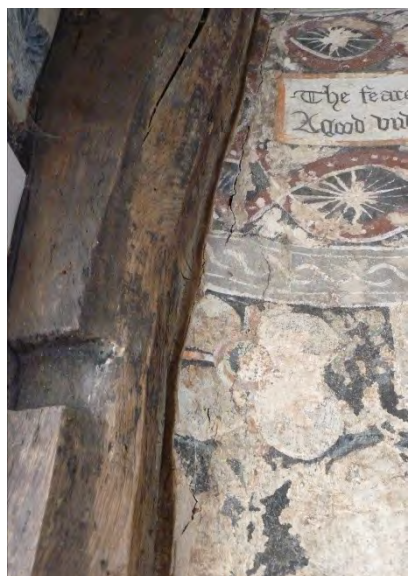
Fig 15.6  
As above, to historic plasterwork.
