Schedule of Condition

**The Market House
Ledbury**

**Job No: 26282
Date: 19 July 2013**

Prepared By: Andrew Harris MRICS PMP RMaPS B.Com Dip.Surv

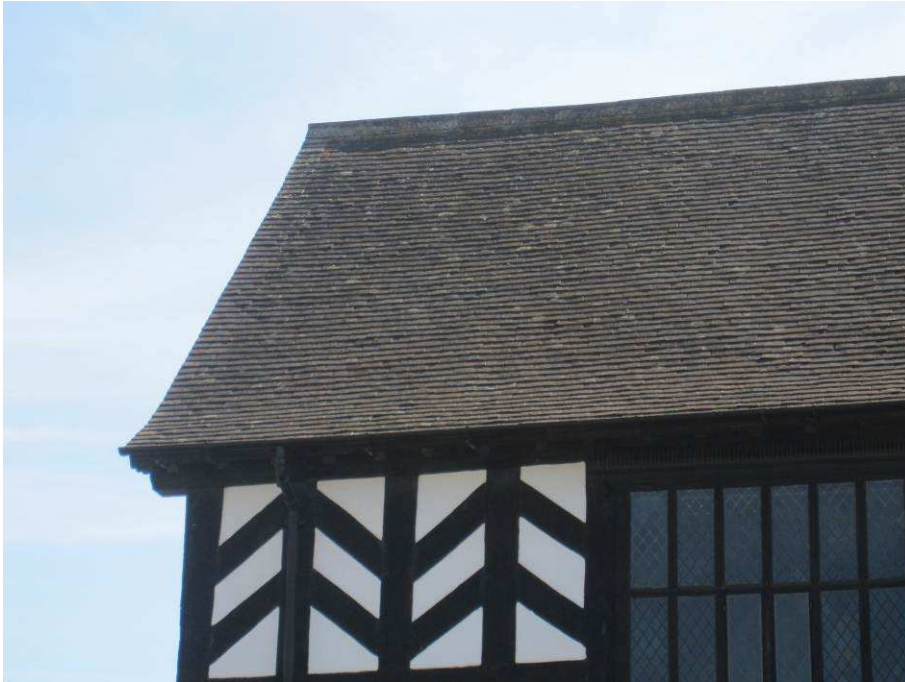
The main dual pitched roof is formed of internally exposed oak timber purlins and rafters supporting timber roof deck overlaid with timber battens and plain clay tiled roof covering. The projecting eaves overhang is supported off the timber frame. Eaves gutters run the full length of the building to either side falling to downpipes and gullies at each corner of the building. The main roof is capped at ridge level with clay ridge tiles. (Refer Photo 2)

Photo 2 View of left hand side of roof on west elevation

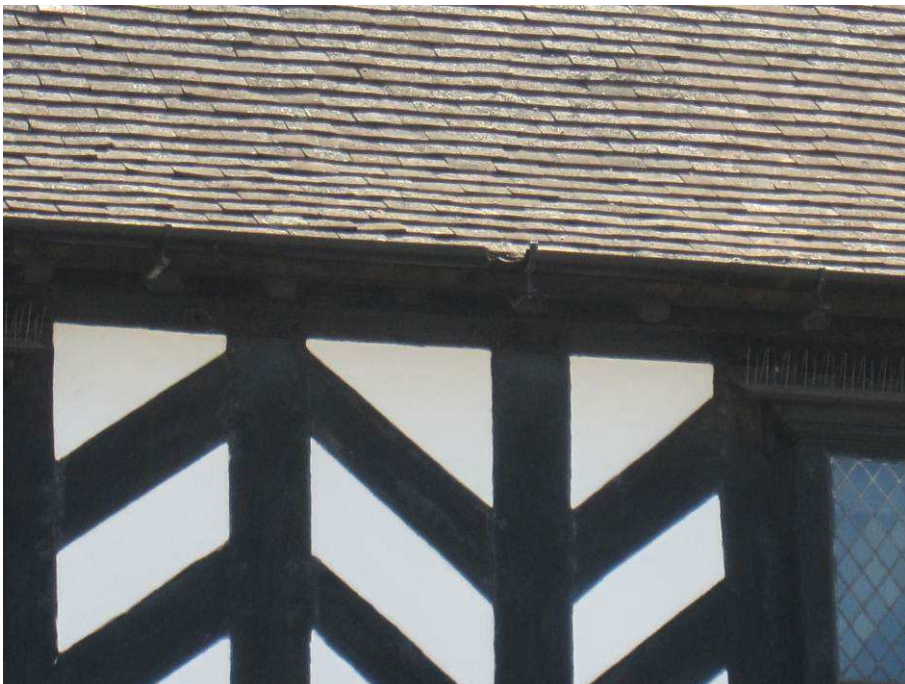
- The roof structures and covering appear to be in a generally good condition with no significant water ingress noted internally during our inspection.
- However, some minor defects were noted that will require attention in the short term, including a small number of tiles noted to be missing or loose (particularly to the High Street pitch); broken section of guttering at mid-elevation to the High Street pitch; and damaged ridge tile at mid-elevation.
- Due to the immediate surrounds of the building being open and accessible to the general public and the steep pitch of the roof, loose or slipped tiles present a health and safety risk and liability. We would therefore advise that consideration be given to installing a form of guard at the base of each roof pitch in order to catch slipped tiles. (Refer Photos 3-5)

Photo 3 Broken section of guttering to west elevation

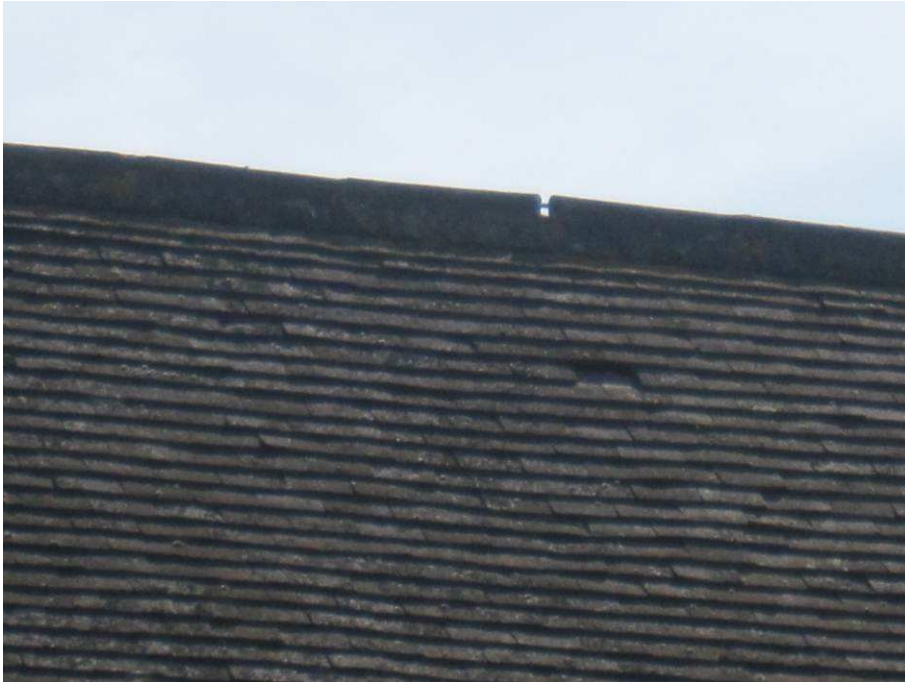
Photo 4 Missing tile and missing pointing to ridge tiles on west elevation

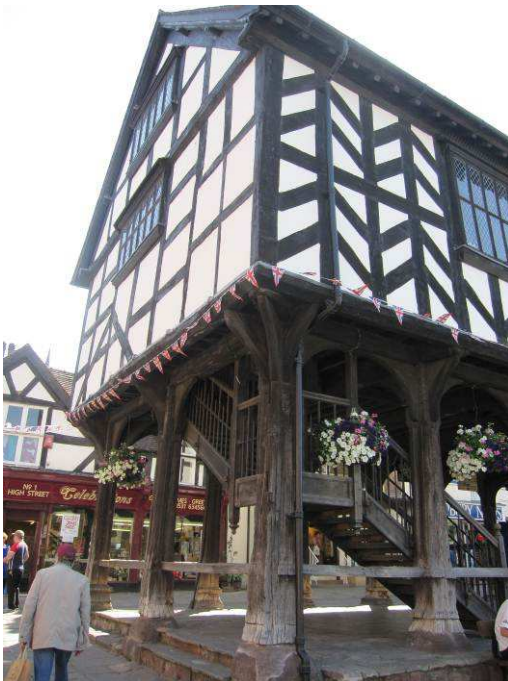
Photo 5 View of rainwater goods to north west corner of the building

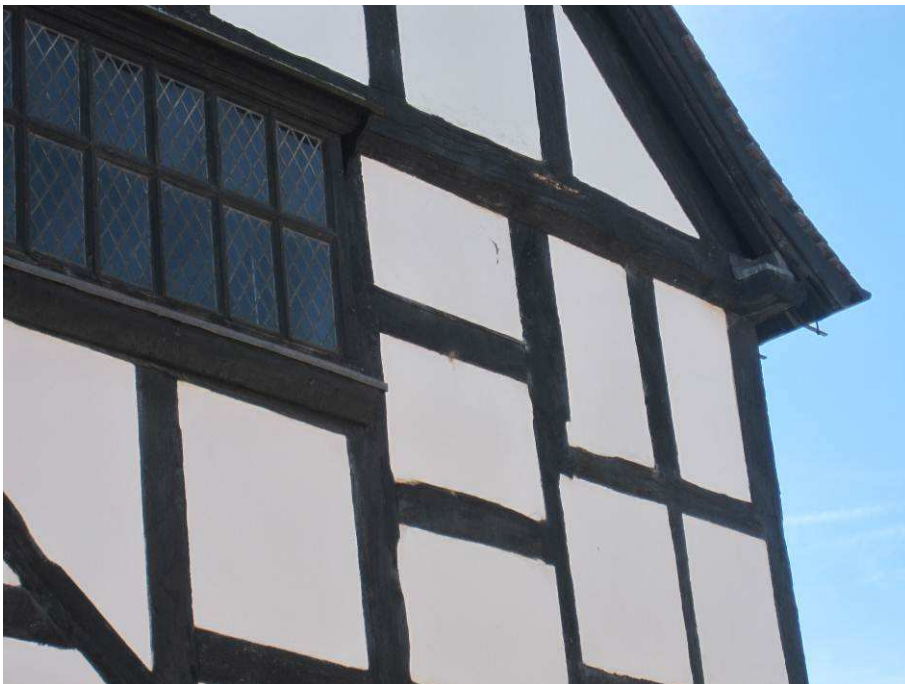
The high level gable ends to the north and south elevations are supported off the wall plates to the top of the timber wall frame. To the south elevation the windows and gable cill on the wall plate are dressed in lead flashings. It was noted that the jettied north elevation projects from the lower level face of the building set flush with the edge of the timber wall plate. There is no lead dressing to this junction (Refer Photo 9).

Photo 9 View of high level gable cill to north elevation and 3 no damaged panels

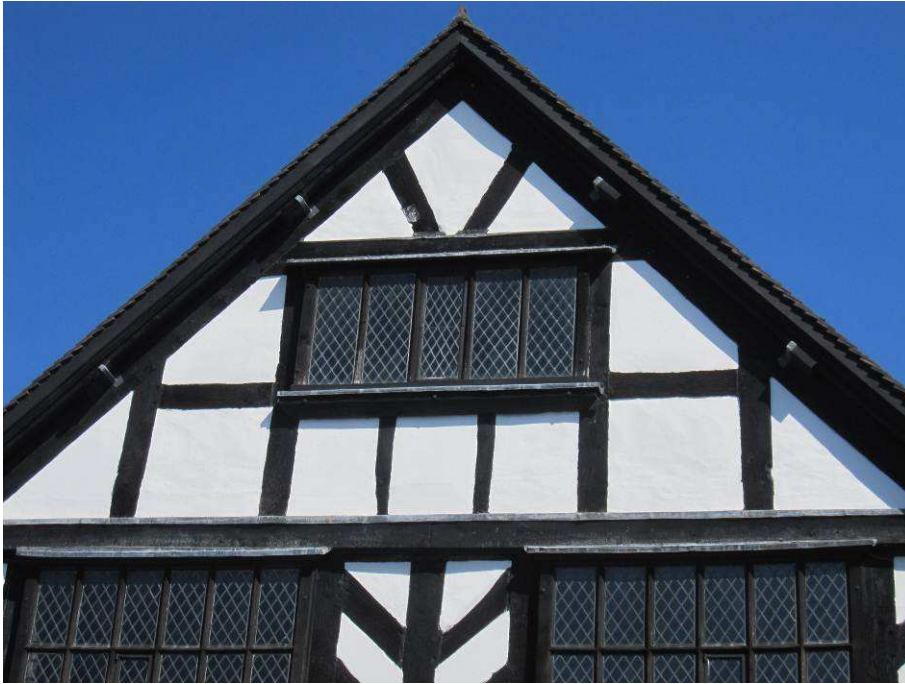
- Decorations to infill panels were generally noted to be in good condition. The decorations to the timber structural frame and sub-frame elements are noted to be in fair condition, with areas of flaking finishes noted, particularly to the south and east facing elevations (Refer Photo 10).

Photo 10 Faded decorations to timber elements to south elevation at high level

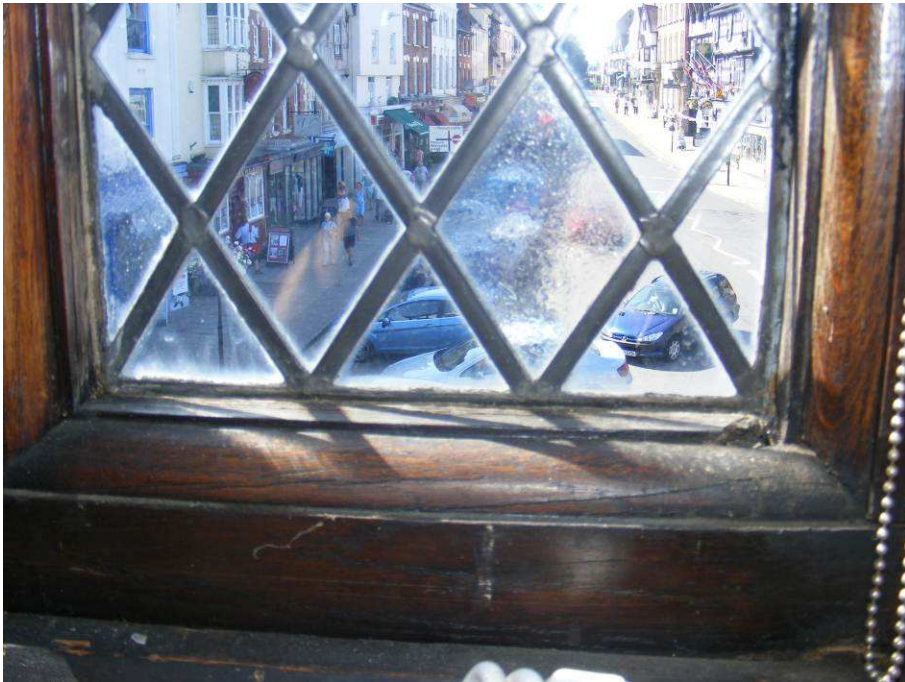
- Localised areas of wet rot were noted to the base of a number of windows, particularly to corners (Refer Photo 11), which we would typically expect to find in windows of this age and

construction. Repairs will be required in the short to medium term to prevent further deterioration to window frames and to prevent damage to building fabric.

Photo 11 Localised disrepair to base of windows

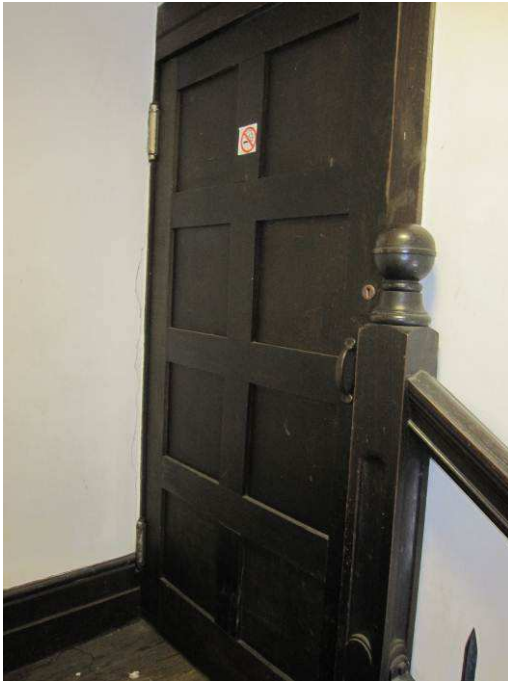
- The main entrance door is considered to be in fair condition given its age and situation. It was noted that the ironmongery and arrangement of the door does not comply with current regulations.
- The external staircase leading to the main entrance is considered to be in a fair condition given its age and situation. Again, it is noted that the handrail configuration does not comply with current regulations.
- Decorations to the door and staircase are generally in fair condition and we would recommend that redecoration is required within the short to medium term.

Photo 12 External view of entrance door

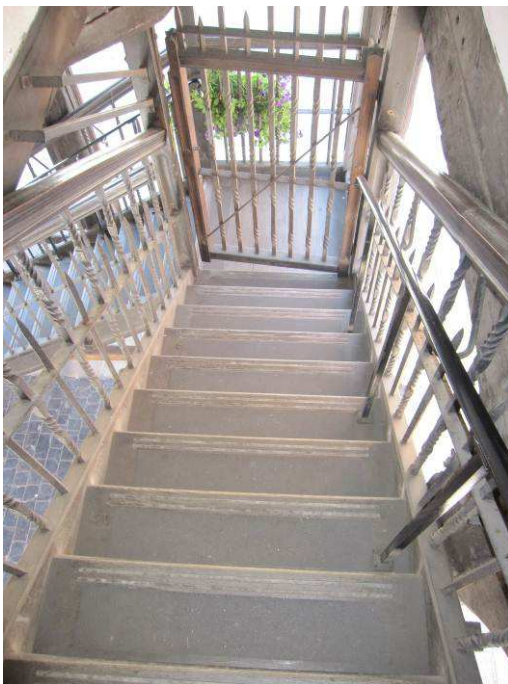
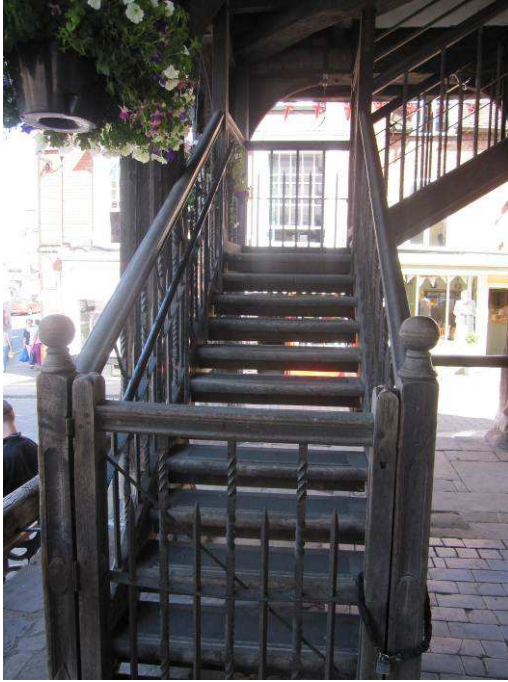
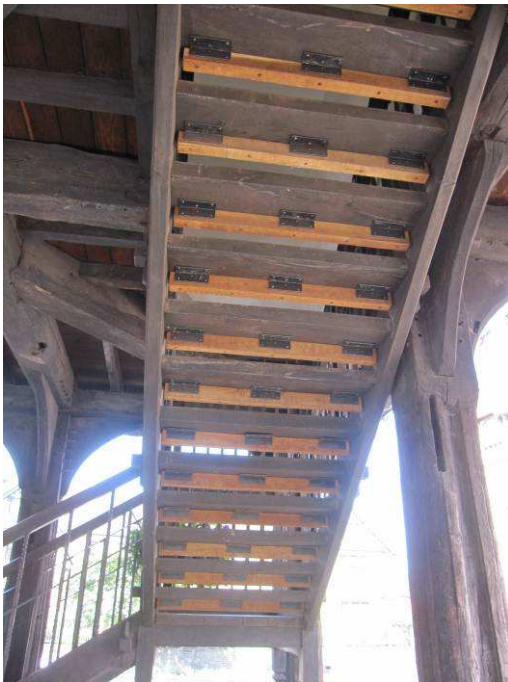
The access staircase is formed of timber newel posts and stringers supported from the structural timber beams and columns. The staircase is configured with a 90 degree turn at the half-landing with an enclosed lobby at first floor landing level at the main entrance door. There is a security gate at the base of the staircase and also at the bottom step of the half-landing formed of timber with iron railings. The staircase has timber treads with open risers, although we note that a half-closing piece has been retrospectively fitted to the underside of each step at the leading edge, which we presume is a health and safety measure. The nosings of each step are not contrasted, however grooves have been cut to the nosing of each step and non-slip surfacing has been applied, again for health and safety reasons. The staircase is enclosed by timber handrails supported off decorative metal balustrading to both sides up to a height of circa 1.2m. A metal low level handrail has also been retrospectively fitted to one side of the staircase to assist users. (Refer Photos 13-15)

Photo 13 View of staircase from first floor landing level

Photo 14 **View of staircase from ground level**

Photo 15 **View of underside of staircase**

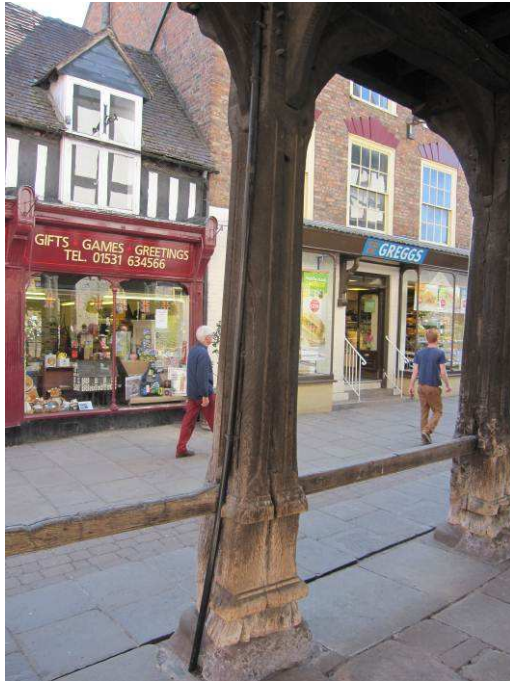
Visual inspection of the foundations is not possible as they are below ground level, and the depth and substrata of the foundations has not been ascertained as part of this survey. However, the building is supported by 16 No oak columns built off stone padstones. (Refer Photo 16)

We understand that extensive remedial works have been undertaken to the base of the columns and the padstones in circa 2006, and we did not identify any signs of stress or defects that would suggest structural failure during the course of our inspection.

Photo 16 **View of oak columns supported off stone headstones**

- Consideration should be given to applying protective finishes to the supporting timber structure, which should be reviewed in line with remedial works undertaken to supporting columns in 2006, and specialist advice in respect of protections to the 16no. oak columns.

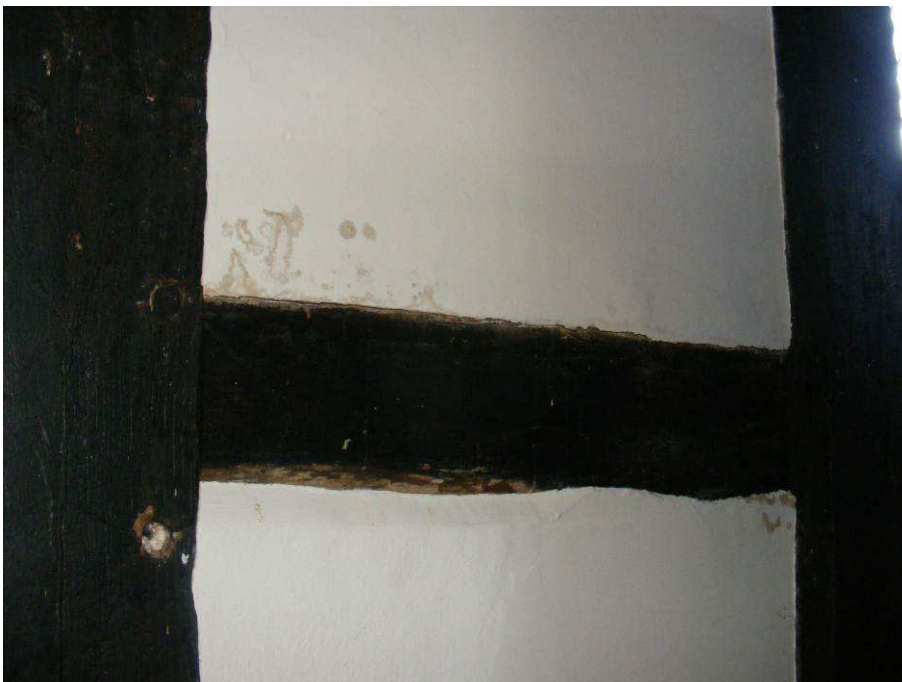
- The internal areas generally appear to be in good order and we understand that redecorations were undertaken during the course of refurbishment works in circa 2006.
- During our inspection we noted a number of incidents of localised water damage due to joints between infill panels and structural frame. (Refer Photo 21) Following completion of remedial repairs to external elevations, consideration should be given to redecorating internal areas throughout. For budgeting purposes, we have allowed costs associated with redecorations of walls, floors, ceilings and timber frame elements to be undertaken within the short to medium term.

Photo 21 General view of water damage to inside face of infill panel due to defective joints

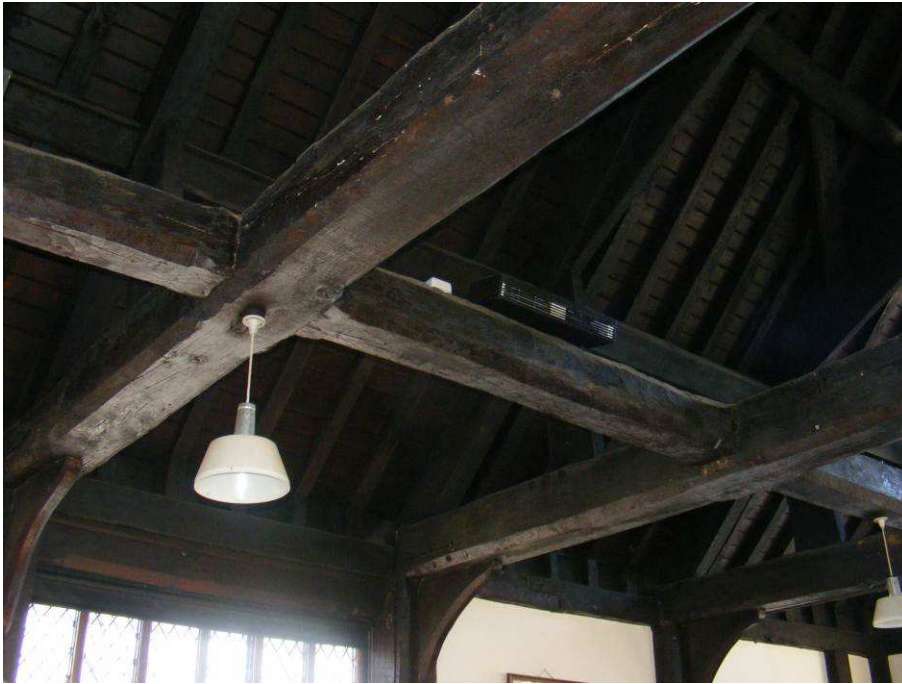
the heating system nor the high level fans were in operation at the time of our inspection. We have not been provided with any certification regarding the heating system, and would advise that these are routinely checked, particularly with regards to the fan heaters to the beams at eaves height due to the potential for accumulation of dust in these units. (Refer Photos 22 & 23)

Photo 22 View of fan heaters situated on top of roof beams

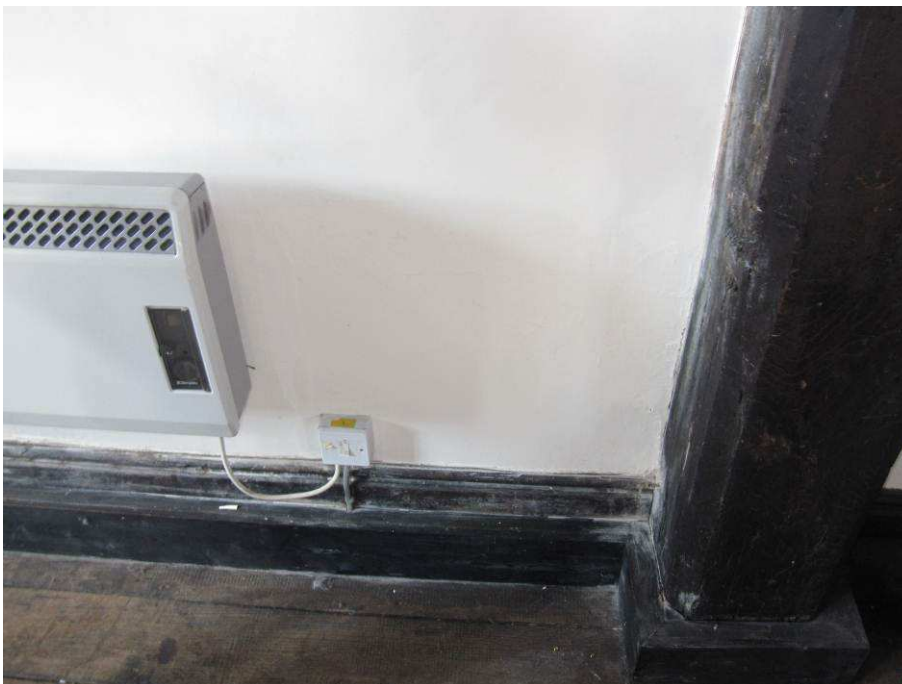
Photo 23 View of night storage heater positioned to perimeter of first floor

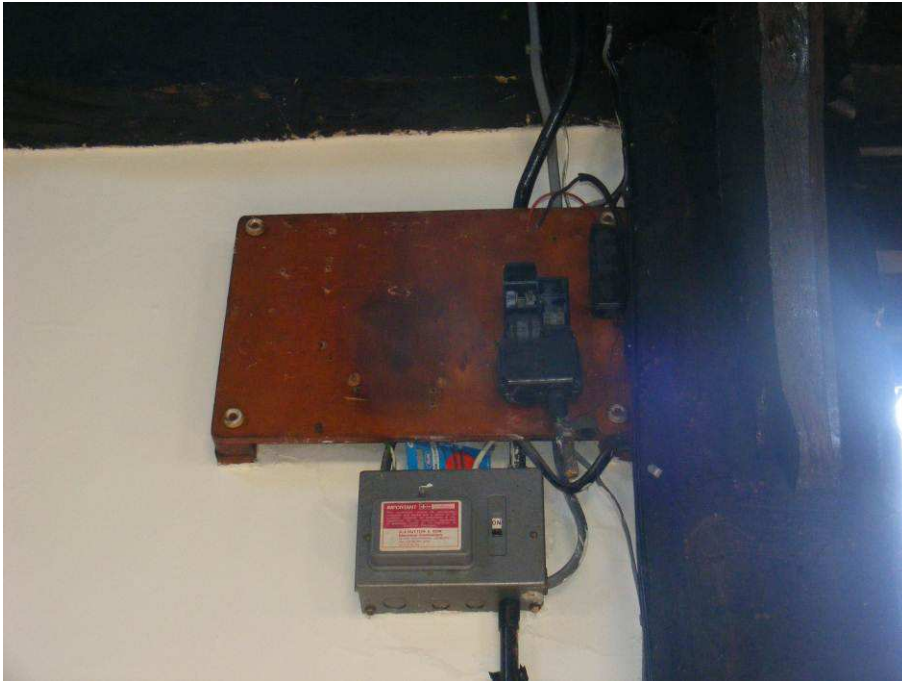
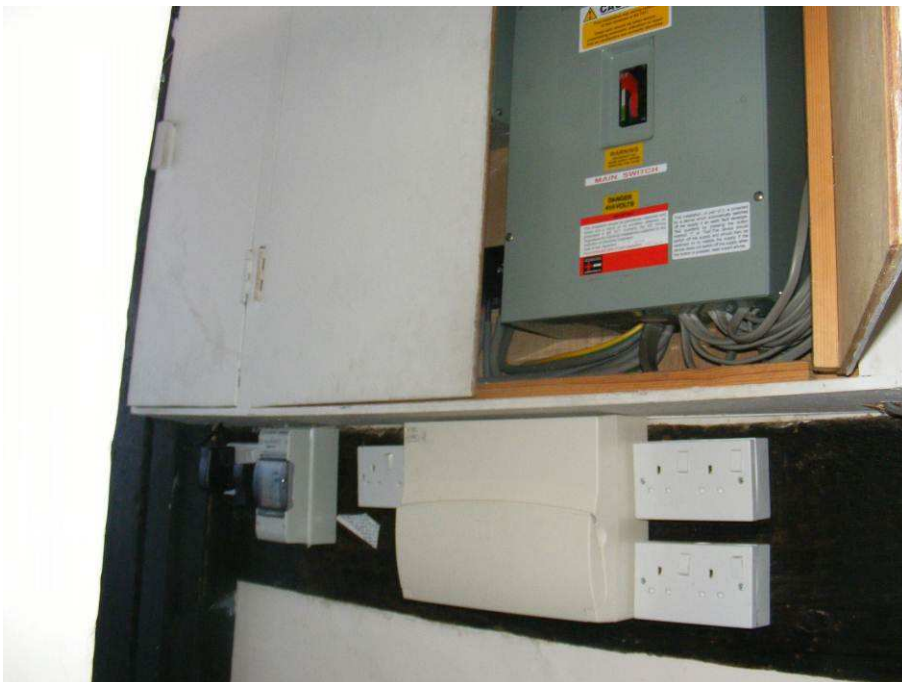
The electrical mains incoming is located to the north-east corner of the property. The main incoming isolator and meter and primary distribution board are fixed to the north elevation housed within a timber meter cupboard fixed to an infill panel. (Refer Photos 24 & 25)

- The electrical distribution appears to be in generally good condition commensurate with its age, with no significant defects noted.
- We have not been provided with any electrical periodic inspection or service reports and we would advise that this is reviewed to ensure that existing installation complies with current regulations.
- We note that the property is not provided with a dedicated fire detection or alarm system and we would advise that consideration be given to installing smoke detection linked to a Redcare system as a measure to assist in preservation of both life and building fabric in the event of fire.

Photo 24 View of electrical distribution board

Photo 25 View of mains incoming and isolation switch positioned on north wall

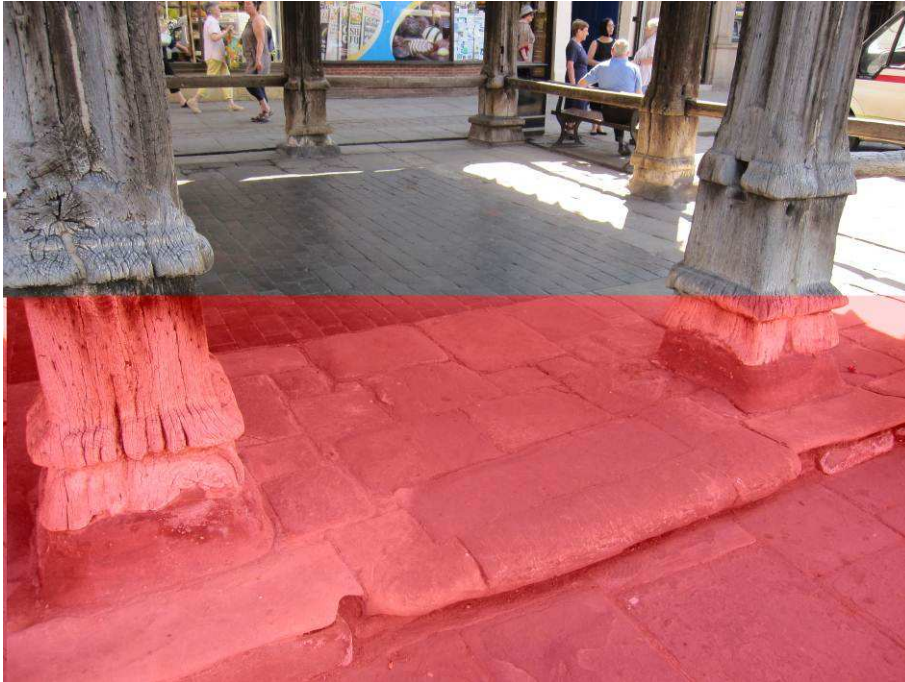
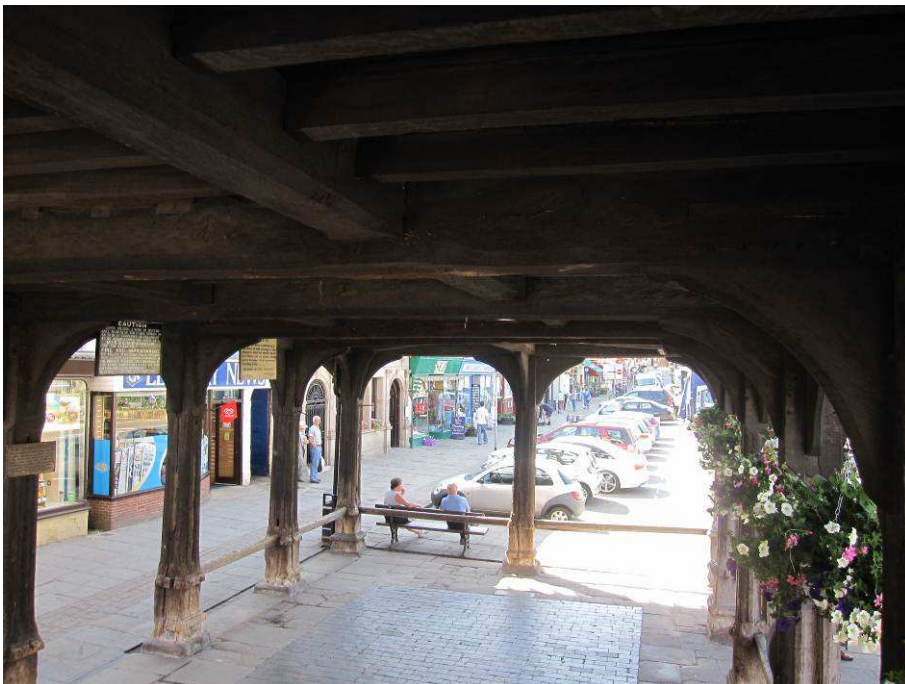
- The external areas are generally noted to be in a fair condition, however we noted areas of uneven and cracked blue brick paviours and uneven flags to the perimeter of the ground level footprint. These areas present a potential trip hazard risk and should be reviewed as part of your risk assessment procedures. (Refer Photos 26 & 27)

Photo 26 View of access to underneath the building from west elevation

Photo 27 General view of external paving to underside of building
