CONDITION SURVEY

Project: LEDBURY War Memorial

Date of Inspection: 29th July, AM Conditions: Cloudy, previous light rain.

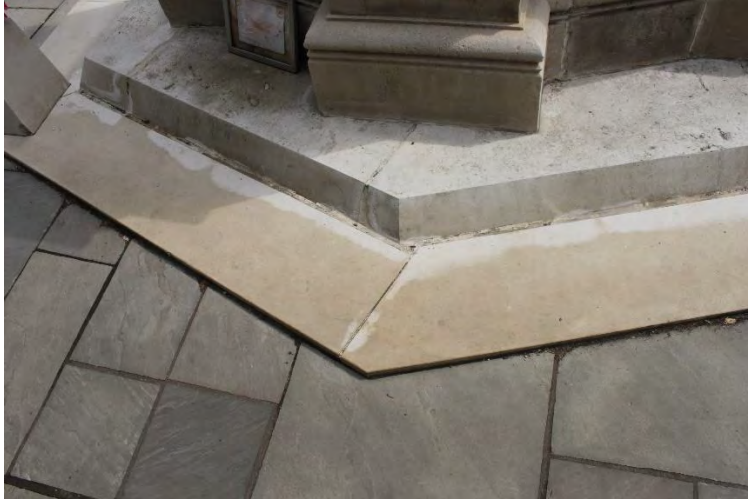
- 3.8. Joints in flags are of irregular widths, 3mm in some places and 15mm in others. Pointing is slightly recessed to some joints and flush with the paving elsewhere, this may be due to wear or cleaning following the paving's installation.
- 3.9. Information on the slip or skid resistance of paving was not provided, we strongly recommend this is confirmed to ensure the safety of the users of the footpath.
- 3.10. The engraved stone commemorating Mr Stuart Heaton's donation is attractive, and natural stone flags are an appropriate choice to compliment the historic setting while maintaining its function as a main pedestrian route. Visually, a better colour and coursing match with the adjacent stone flags would be desirable.

I.1 Uneven joints, and salt staining to paving stones

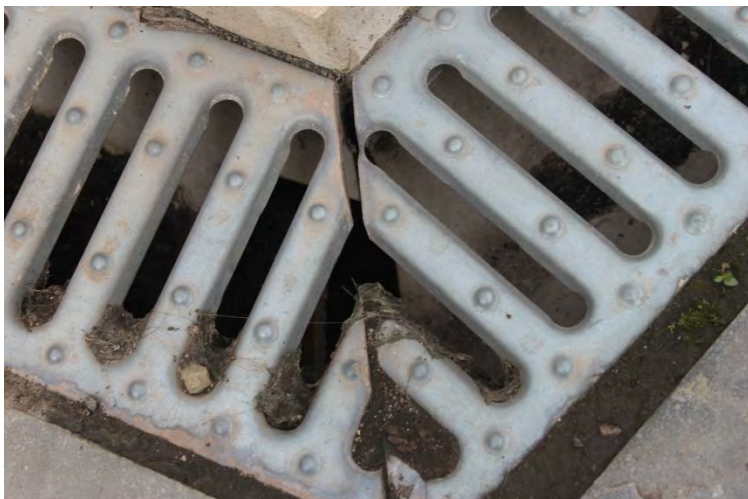
- 4.1. The ACO channel drain is presumed to be polymer concrete with a galvanized steel grating. Its lightweight appearance suggests it's an 'extra light duty' or Load Class A drain, suitable for domestic occasional foot traffic. This is not an equivalent to the more durable Load Class B drain specified.

- 4.3. The grating can be easily lifted for inspection and the removal of any debris. The channel itself appears suitably sized.
- 4.4. The grating was slightly damaged at the corners. The trip hazard posed by missing or distorted grating and the uneven ledge to the paving is of concern.

I.2 Unsupported edges and flimsy material to ACO grating.

- 11.4. At the same time the ACO channel should be renewed with one appropriate to the usage of this area, and grouting carried out to the base of the monument, further advice should be sought from a structural engineer on the base detail as installed.

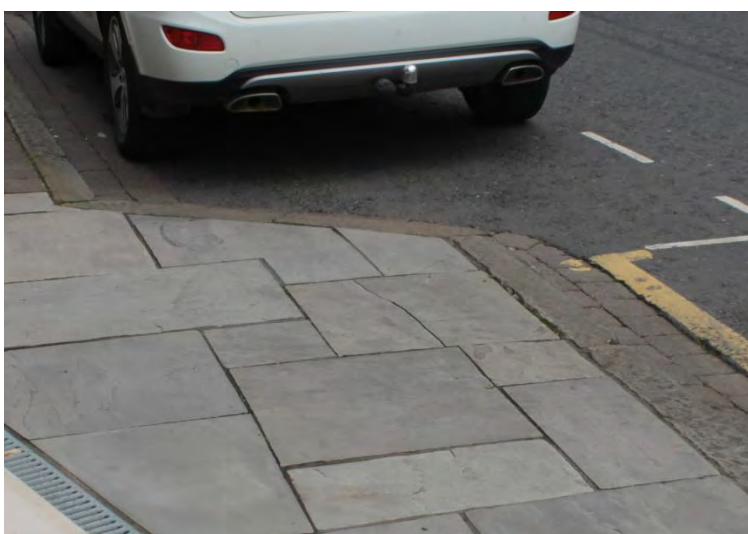
- 3.5. Flags have cracked where adjacent to the stone kerb and this clearly corresponds to where vehicles have over-run. This has caused a trip hazard which is likely to get worse.

- 10.3.3. Fractured paving also presents a new trip hazard, pedestrians would be on guard for surface irregularities with the previously cobbled surface, but would not anticipate them in newly laid paving. There is the potential for further fracturing and instability to the paving.

I.3 Fractured paving flags by kerb

- 11.2. The monument and area around it should be observed during or after heavy rainfall to ensure the drainage is performing as required.
- 11.3. Paving should be lifted to verify the inadequate thickness, and the bedding should be inspected at the same time to ensure it is appropriate for the expected traffic to this area. Paving should be renewed with dimensions suitable for the type of traffic, so for occasional vehicle over-run by the kerb, and for regular pedestrian traffic to the rest. The bedding of the paving should be improved as needed. New stone flags should be installed following approval of samples and product data sheets, and should be set to avoid trip hazards adjacent to the monument and where it meets existing paving.

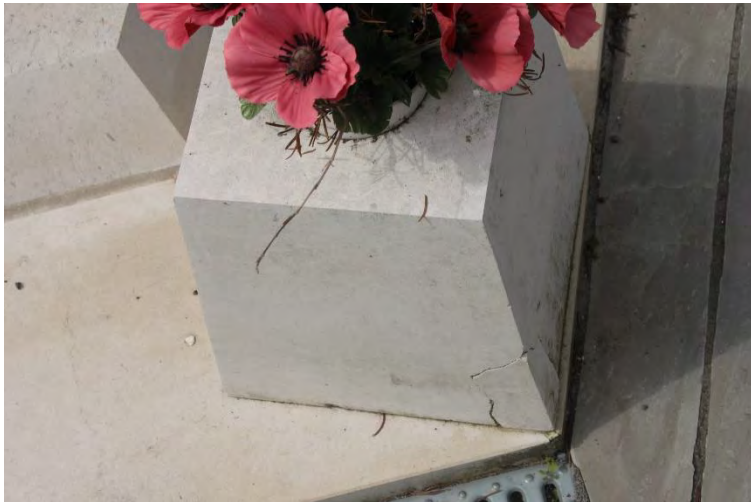
- 10.3.4. Flower vases that are unfixed and with sharp edges may cause a risk of injury, the placement of them on the monument should be considered. The previous location on the upper step of the monument was less likely to trip people.

2.1 Damage to edge of stone
flower vase

- 11.1. A risk assessment should be carried out addressing the trip hazards presented by the new drainage channel and surface finishes, and the unfixed flower vases. This should include confirmation of the slip resistance of the paving.

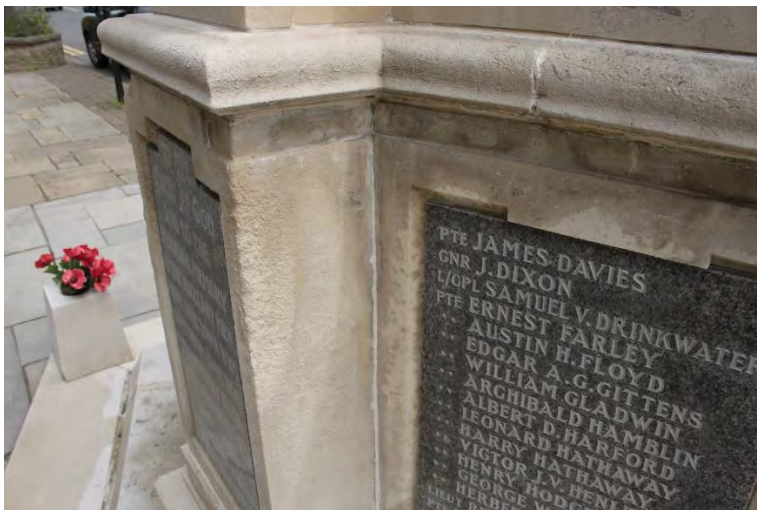
2.2 Eroded stone mouldings and
face

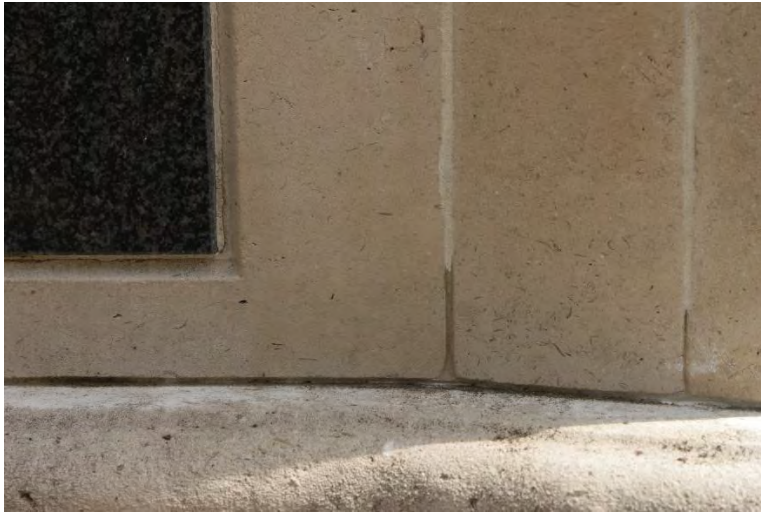
- 7.3. There does not appear to have been an attempt to match the new mortar to existing pointing and stonework, as pointing is a poor match. It may blend in further as it weathers. Mortar appears to be very hard, it could be a strong hydraulic or cement mix.

- 7.4. Pointing appears to be flush with the face of the stone and follows the irregularities of the stonework. Joints which have been previously pointed with possibly resin based mortar have not been raked out fully, this gives an untidy appearance where old mortar meets new. Leaving sound hard mortar intact can prevent damage to stonework caused by its removal.

3.1 New pointing to stonework

- 11.6. Repointing in lime mortar, following samples (an NHL 2 mix may be appropriate here) including thoroughly filling voids behind failing mortar should be carried out throughout.

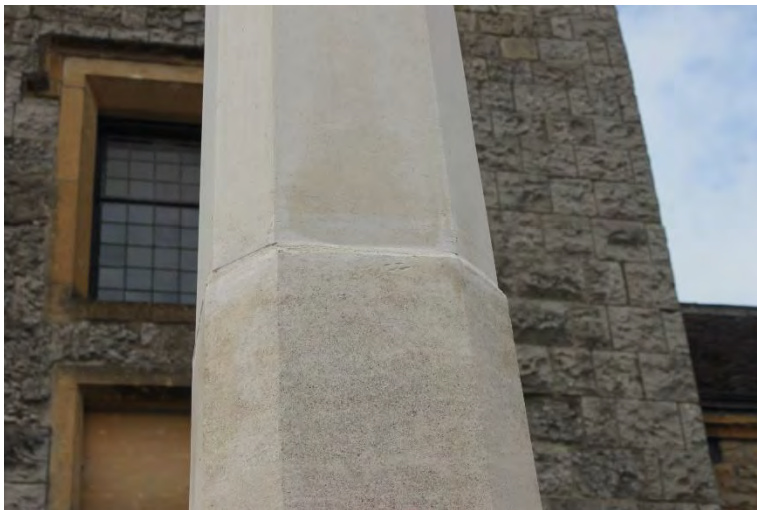
- 6.1. Sources of Portland Limestone are increasingly scarce in the UK, the visual match of replacement stone is currently only fair and may blend in as it weathers.
- 6.2. Following renewal of a stone to the obelisk, the arrises do not line up and the monument has lost its visual crispness. The new section of stone does not appear to be to the original profile.
- 6.3. The joint between the new and the original stone is large and uneven, approx. 12mm wide in some places, and ledges have been created where the lower stone projects further out, which will accelerate the weathering of it and cause more distortion of it from its original profile.
- 6.4. The fixing of the stone has not been confirmed, this should be checked to ensure structural stability.

- 10.5.4. The workmanship involved in the replacement stone to the monument obelisk is not of a sufficient standard for this Grade II listed structure. Good practice, which an experienced stonemason should be aware of, is to cut and finish replacement stone to match the original lines and not the weathered profile, with fine joints to match those elsewhere in the monument (measured at 4mm). This is important to ensure the entire monument continues to function and weather as originally designed, and makes the historic profile of the stone easier to read.

3.2 Inadequately shaped new stone

- 11.5. It is our opinion that the quality of workmanship during the stone renewal to the column is insufficient and not appropriate for this historic listed monument, stone should be replaced by a suitably experienced craftsman following approval of samples.

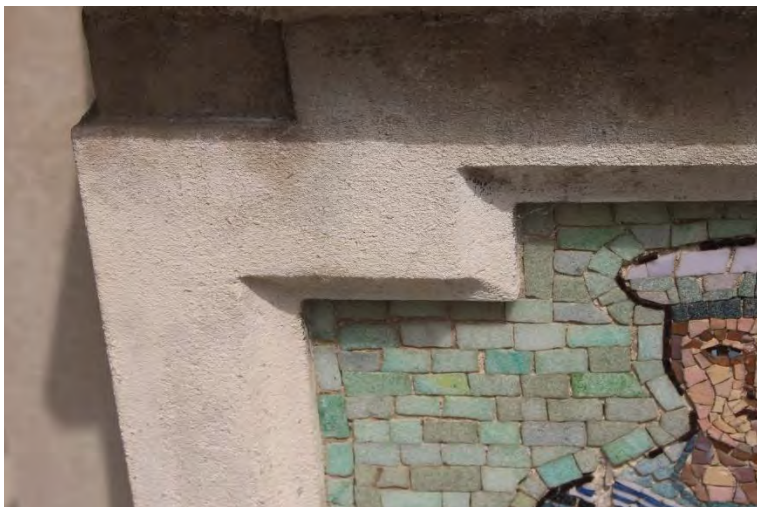
- 8.1. Granite plaques have been kept sparklingly clean and the inscriptions are thoroughly painted.
- 8.2. Painted ceramic tiles appear bright and undamaged.
- 8.3. Pointing to mosaic tesserae has eroded, so the edges of the tesserae are exposed. There are small amounts of missing tiles, most noticeably to the sailor's hand. Abrasive or too frequent cleaning methods may have worsened the condition of the pointing and tiles.

3.3 Eroded pointing and missing mosaic tesserae

- 11.7. Repointing, and potentially grouting of the substrate and replacement of missing mosaic tesserae should be carried out by a suitably experienced conservator.
