# TIMBER ASSESSMENT

COUNCIL OFFICES

MARKET HALL

LEDBURY

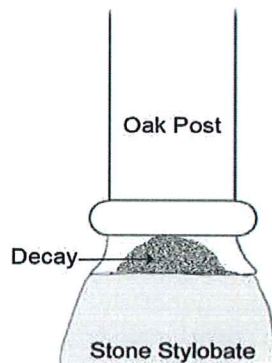
Figure 1. Typical pattern of decay in post base

- 5.01 A brief visual assessment of the first floor interior was carried out. No significant degradation was identified and surface moisture content was below 18%mc. However, there is a 'musty' smell, and the space does not appear to be adequately ventilated.
- 5.02 There are some visual indications that degradation is continuing at the junction between the posts and the stone stylobates.
- 5.03 A 2004 report by Demaus Building Diagnostics identified severe to very severe degradation at the base of most of the 16 posts. The most severe degradation was generally confined to the lowest 50mm. The typical pattern of degradation is illustrated in Figure 1.

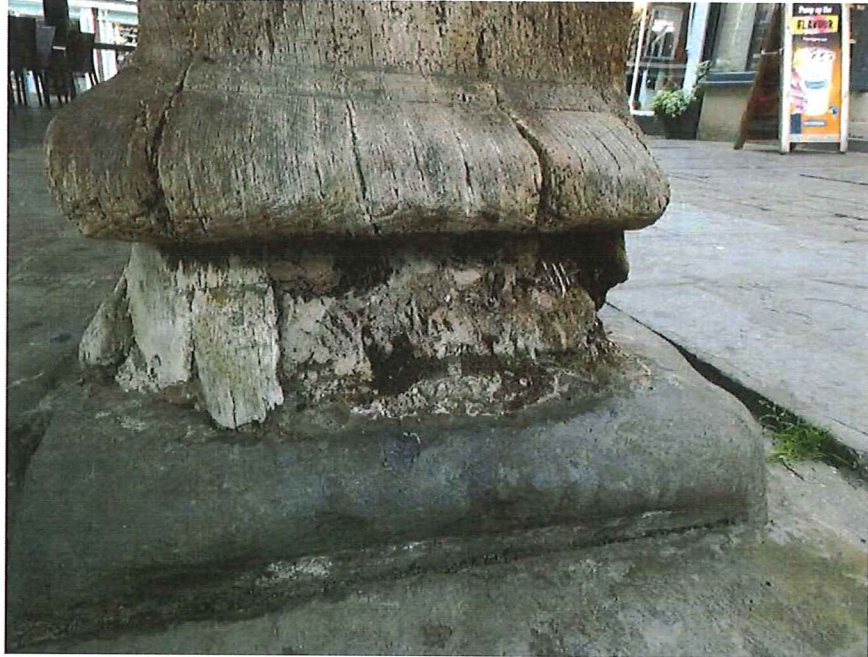
Figure 3. Location A. South face of Post 6

- 5.17 The south face of Post 6 has been lost since the repairs of 2006. Presumably it split off either because of continuing fungal degradation, and/or because compression of the post on the wedge-shaped cone of hard mortar split the section off.

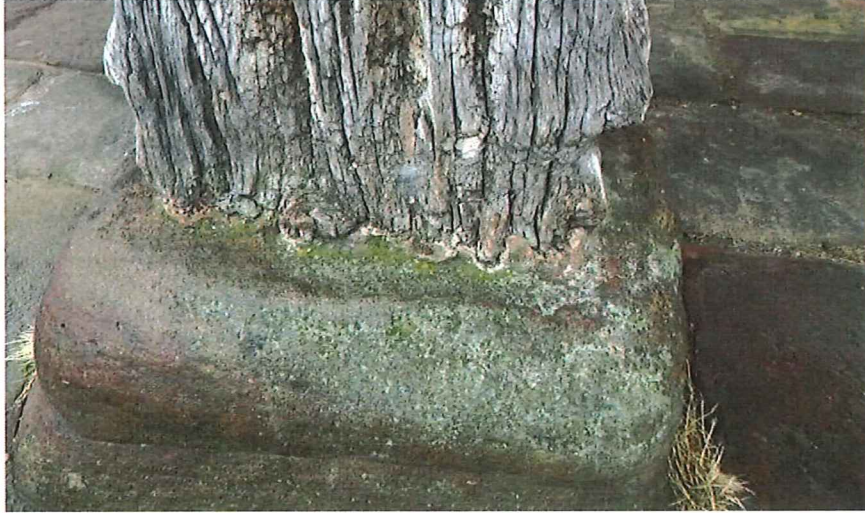
- 5.18 On the south face of Post 8, the mortar, which has emerged from the base of the post (presumably when first cast), acts both as a gutter tending to channel water into the centre, and as a dam, preventing water from escaping.

Figure 5. Location C The mortar at the base of the post creates a gutter

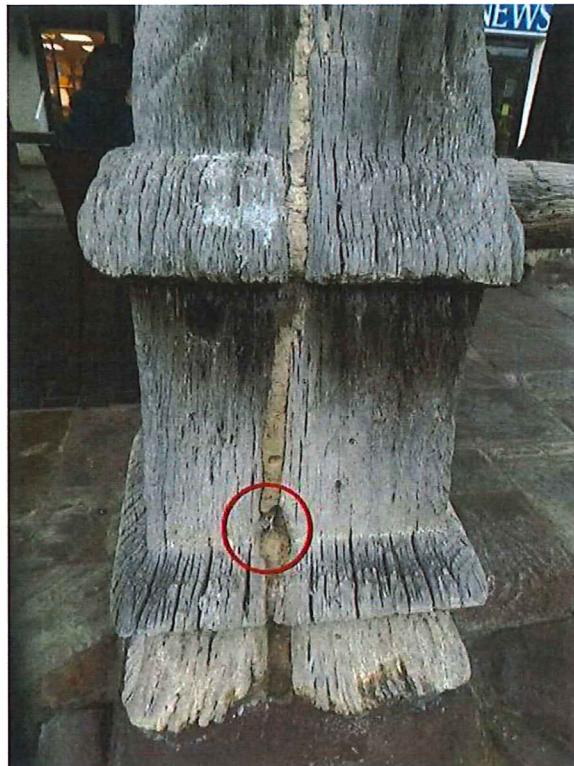
Figure 6. Location D.

- 5.19 The large split in the timber on the west (i.e. exposed) face of Post 10 has been filled with a mortar fillet including stainless steel mesh reinforcement (circled) which is now breaking up.
- 5.20 It is not clear what the intended purpose of this fillet was. Gaps very quickly form at the interface between the mortar and the timber, which encourage moisture (often by capillary action), but also by percolation and penetration deeper into the cross section, where it is held by the mortar against the timber, The same mortar prevents, or greatly restricts, any evaporation.

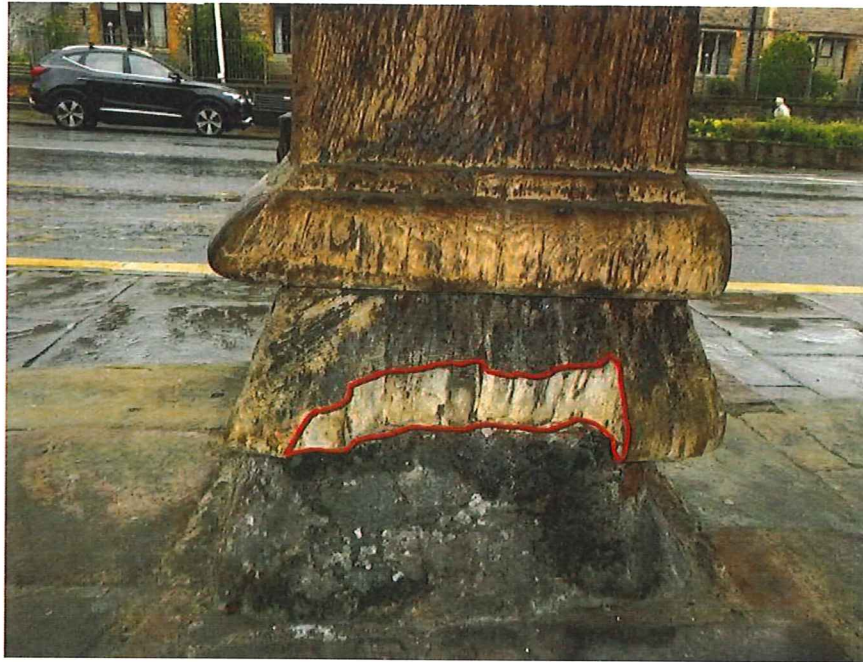
Figure 7. East face of Post 12

- 5.21 The lowest section of the post on the east face (outlined in red in Figure 7) appears to have broken off, possibly due to the wedging action of the cone-shaped hard mortar plug.

- 6.5. The likely shape of the mortar plug (an inverted wedge) will tend to split the timber as it compresses.
- 6.6. The loss of some sections of Posts 6 and 12 may indicate that this process is already happening.

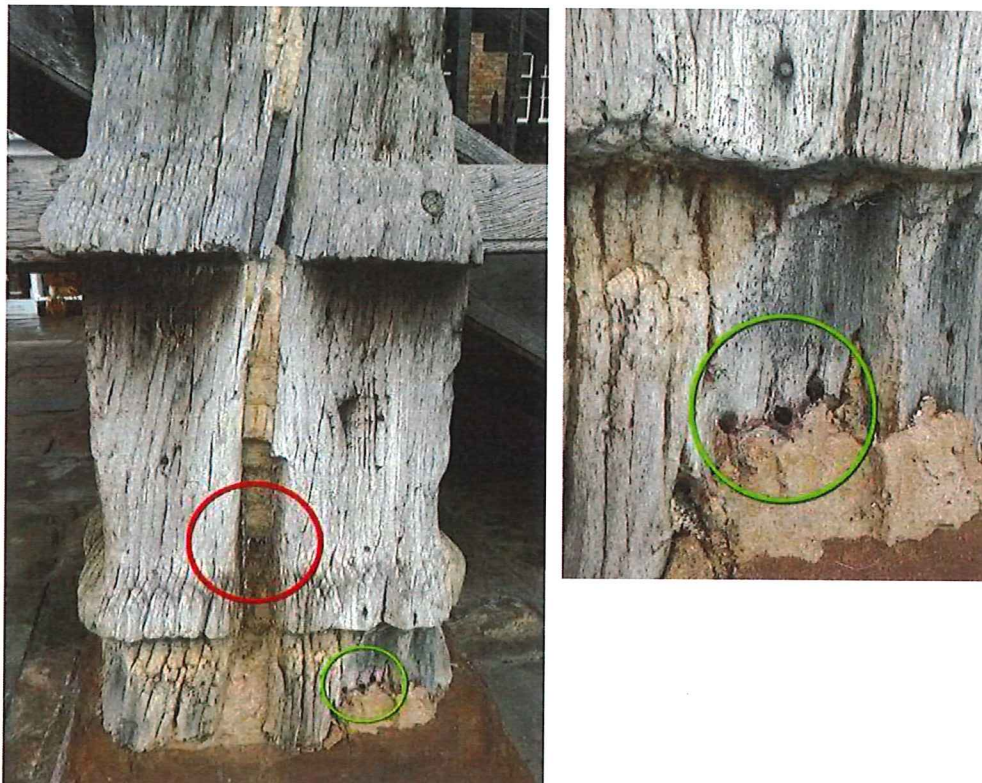
- 5.22 As with Post 10, the mortar filling the split is starting to break up. The holes (circled green and enlarged in Figure 9) may well be emergence holes of wood wasps (*Siricidae* spp) or similar that have re-colonised the degrading timber of the post foot.

Figures 8 & 9. The west face of Post 14 showing the mortar fillet breaking up (circled red) and probable emergence holes of colonising insects (circled green and enlarged in Figure 9).

- 6.7. Wood wasp (or similar) activity was noted in 2004, and it appears that these insects have re-colonised some of the posts. Wood wasps do not actively damage the timber, but will colonise and consume timber that has already degraded due to significant fungal degradation. Their presence is a useful indicators that a problem exists.

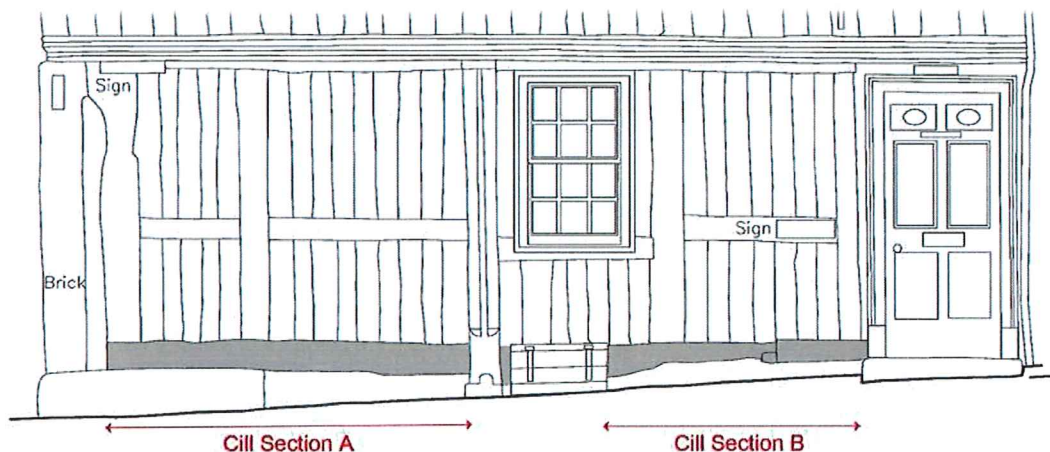
Figure 10. Part south elevation identifying cills.

5.23 Cill Section A: There is minor degradation in the lowest 15mm of the cill, immediately above the plinth masonry. Degradation is likely to be slow, but continuous, and over time the degraded wood will compress.

5.24 Cill Section B: There is 20-30% i.e.s. concentrated along the lower outer area of the cross section as shown in Figure 11.

- 6.15. If the rate of degradation can be reduced, Cill Sections A & B could be retained without structural intervention. The simplest and most cost-effective way to reduce moisture ingress and retention would be to fit pentice boards to protect the existing cills from wetting by rainwater falling directly on the elevation and also (probably more frequently and with greater intensity) splashing up from the surface of Church Lane.

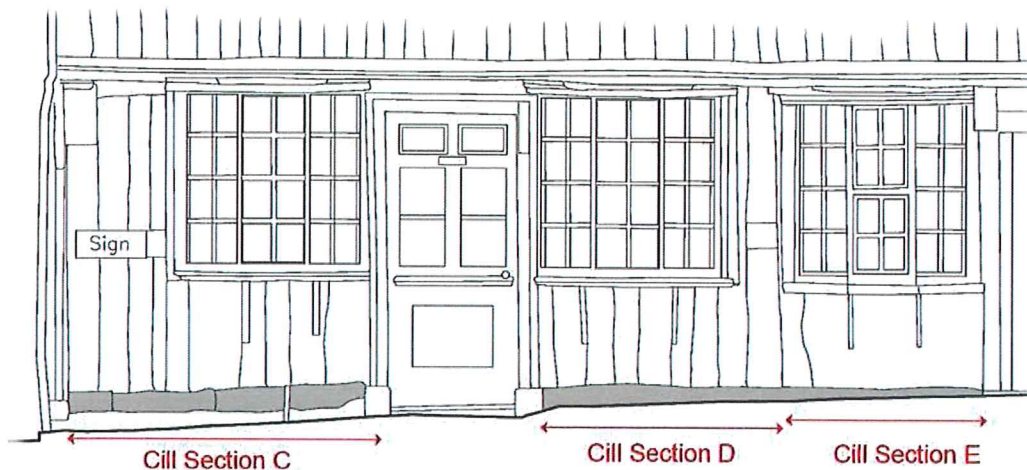
Figure 12. Part south elevation identifying cills.

- 5.25 Cill Section C: There is typically 40-50% I.e.s. caused by a pattern of degradation running along the line of the mortices, which have enlarged to create a hollow section as sketched in Figure 12.

- 5.26 Cill Section D: There is 40-50% I.e.s. along the length of the cill.
- 5.27 Cill Section E: There is typically only 30mm of reasonably sound timber at the outer edge. It appears that an additional timber section has been applied to the inside, but there is no way of confirming the structural fixity

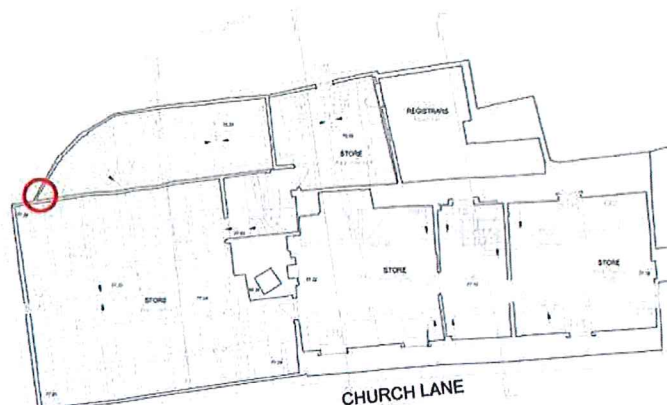
Figure 13. Location of old leak at second floor level.

- 5.28 An internal and external thermographic survey was carried out, but did not identify any significant concealed anomalies.
- 5.29 The staining visible internally at the north west corner (location shown in Figure 13) of the second floor has not changed since it was photographed as part of Caroe & Partners 2018 quinquennial survey, and there is no evidence of current or recent water penetration.

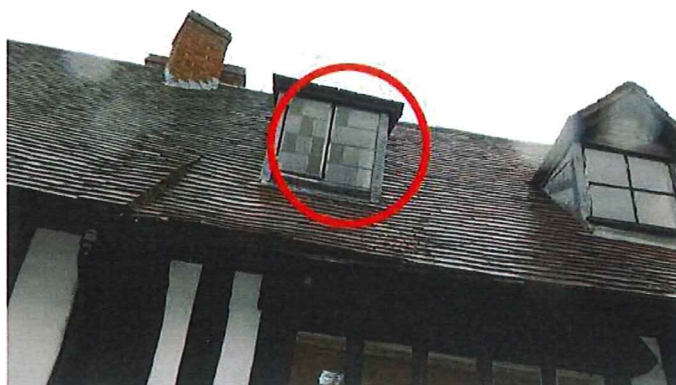
- 5.30 The glazing of the 'fixed' casement of the 2<sup>nd</sup> floor dormer shown in Figure 14 is very poorly fixed and could be sucked out in some wind conditions.

Figure 14 Loose glazing in dormer window circled in red.

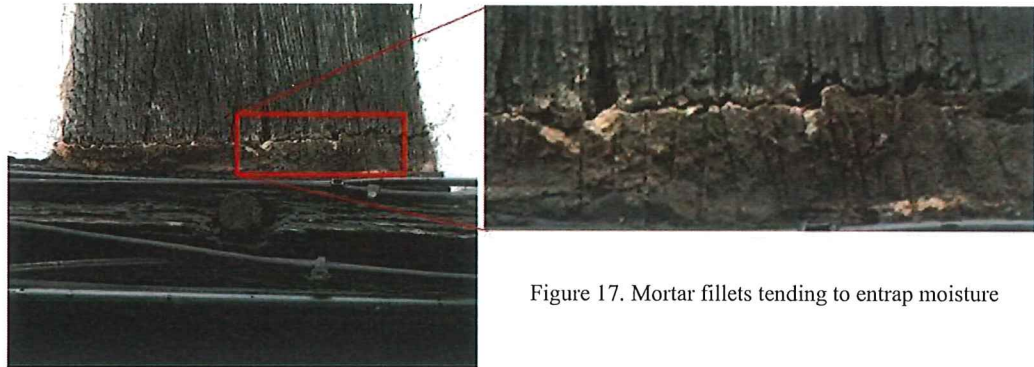
Figure 17. Mortar fillets tending to entrap moisture

- 6.23. These mortar repairs are often carried out with the good intention of preventing moisture entering through open joints etc, but in almost every circumstance they trap moisture rather than disperse it, channelling any water percolating down the surface of the frame deeper into the cross-section. The mortar acts as a sponge, holding moisture against the timber and preventing any evaporation.
- 6.24. Timber patch repairs usually have exactly the same damaging effect.
- 6.25. Wherever possible, such fillets should be removed. Where necessary, other measures such as pentice boards or carefully detailed flashings provide much better protection.
