ENVIRONMENT AND LEISURE COMMITTEE	19 NOVEMBER 2020	AGENDA ITEM: 6(i)
--	-------------------------	--------------------------

RECREATION GROUND

UPDATE ON WORK IDENTIFIED IN THE ANNUAL PLAY INSPECTION REPORT

Recreation Ground Repair or Replacement of Items Listed **SPECIFICATION**

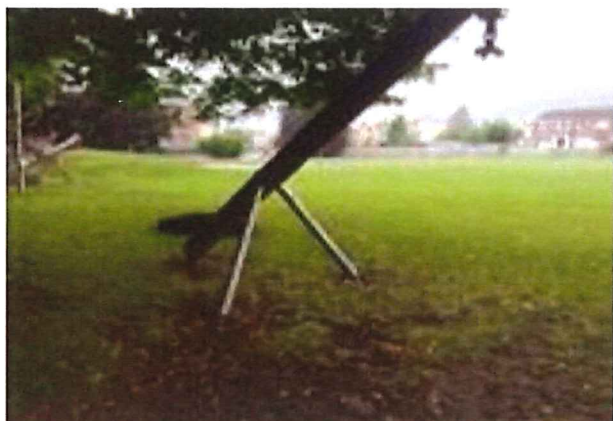
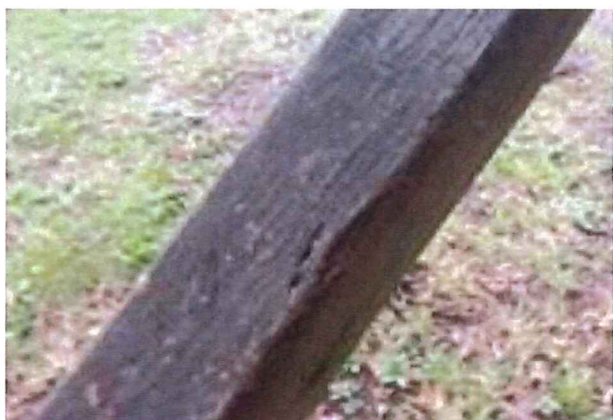
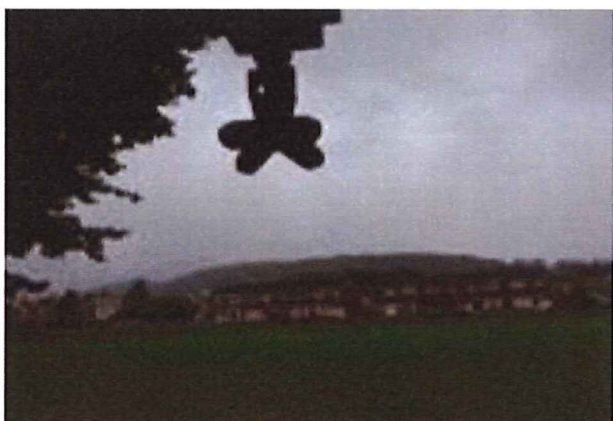
No. 2 Single Point Swing

1 Parts of the timber are rough or splintered

2 The item has missing component(s)

Risk Assessment: 2 x 3

Risk Assessment: 2 x 2

1 Remove all rough or sharp edges

2 Consider replacing missing components

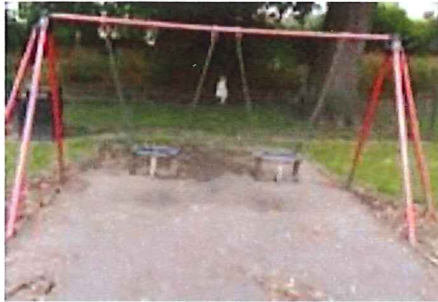
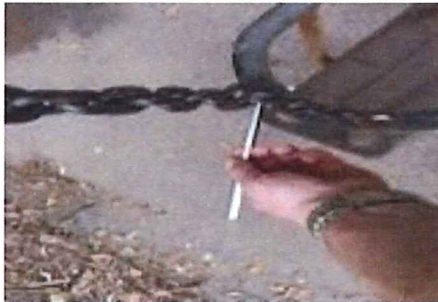
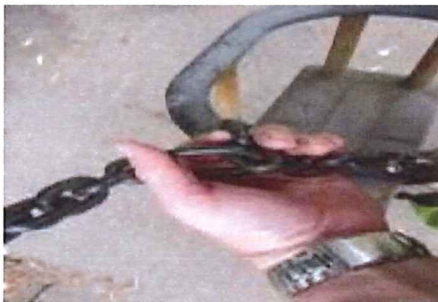
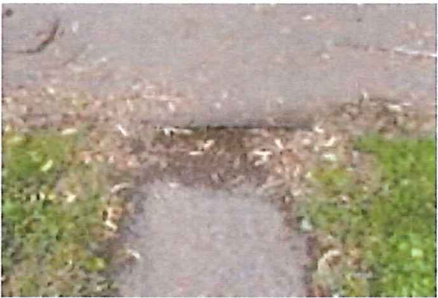
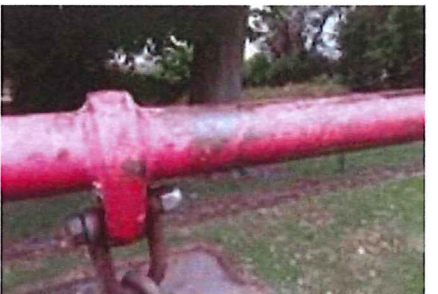
No 3. Bay Cradle Swing

- 1 The chain openings are in excess of the maximum of 8.6mm recommended by BS EN 1176.
- 2 There is some chain wear
- 3 The surface is lifting at the edges and creating trip points
- 4 The paintwork on this item has been damaged or worn exposing the metal underneath which is rusting.

Risk Assessment: 1 x 5

Risk Assessment: 2 x 3

Risk Assessment: 2 x 4

5 The bushes are showing signs of wear

1 Monitor use and replace with compliant chains during next maintenance cycle.

2 Monitor for further deterioration and replace when 40% worn.

3 Repair safety surface

4 Treat any rusting components and repaint

5 Monitor for any further deterioration and repair as and when required.

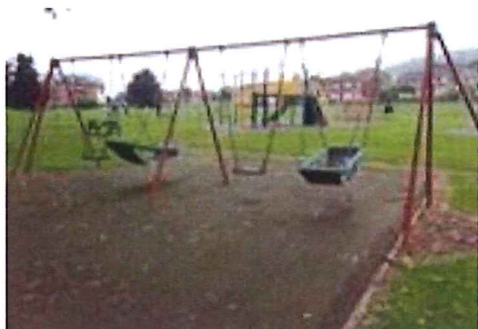
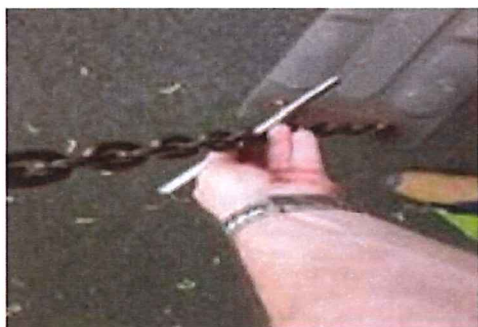
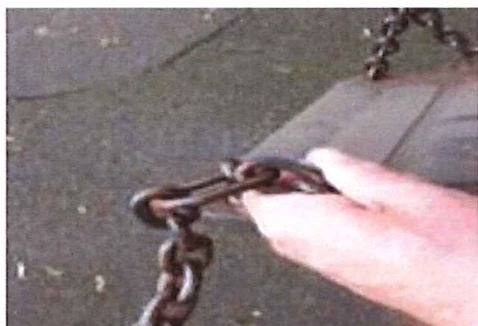
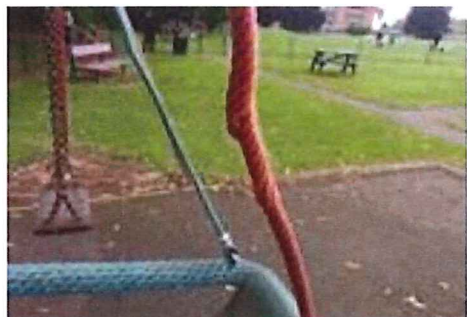
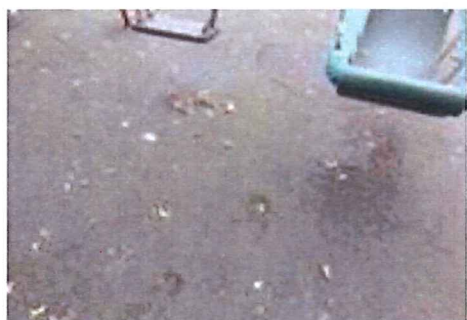
No. 4 2 Bay Mixed Swing

- 1 The chain openings are in excess of the maximum of 8.6mm recommended by BS EN 1176.
- 2 There is some chain wear
- 3 The ropes are worn/damaged in places.
- 4 The safety surfacing is damaged.

Risk Assessment: 1 x 5

Risk Assessment: 2 x 3

Risk Assessment: 2 x 4

- 5 The paintwork on this item has been damaged or worn exposing the metal underneath which is rusting.

- 1 Monitor use and replace with compliant chains during next maintenance cycle.

- 2 Monitor for further deterioration and replace when 40% worn.

- 3 Monitor for any further deterioration and repair or replace as required.

- 4 Repair damaged areas of surfacing

- 5 Treat any rusting components and repaint.

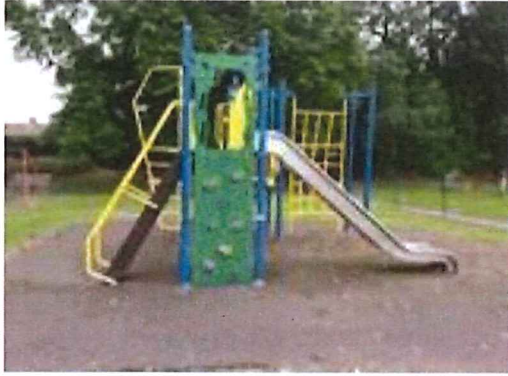
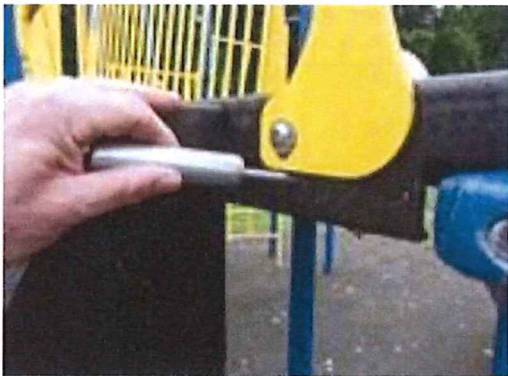
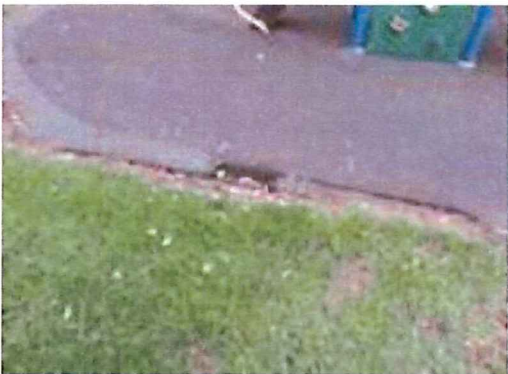
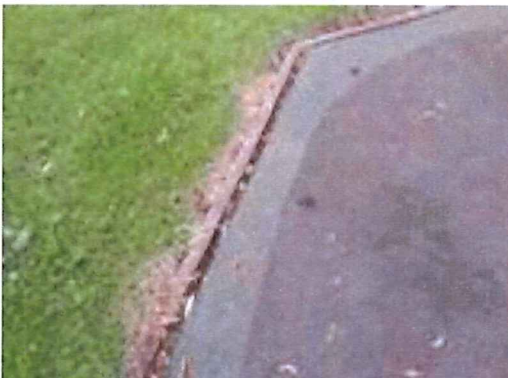
6. Multiplay Slide

1 There is/are finger entrapment(s) in the platform and the item fails to meet the requirements of BS EN 1176:2008 Part 1 4.2.7.6 Entrapment of Fingers.

2 The safety surface is damaged

3 There are gaps opening up at the edges of safety surface

1 Monitor use 1 x 5

Risk Assessment: 2 x 4

2 Repair the safety surface

3 Repair the safety surface

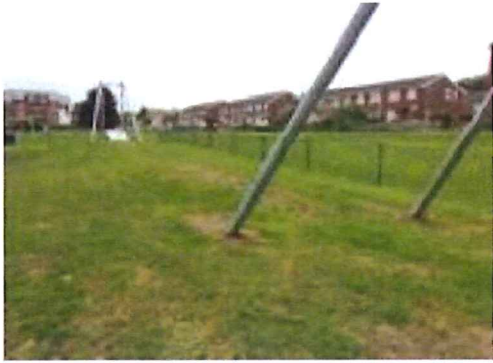
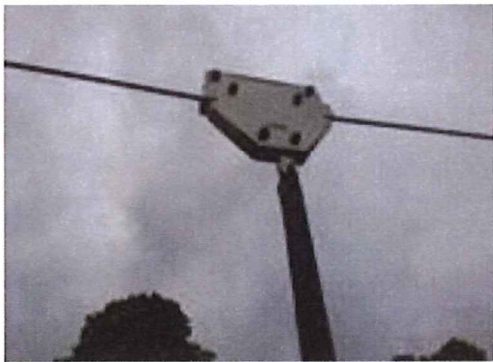
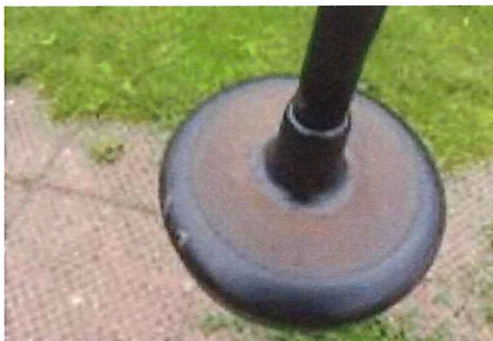
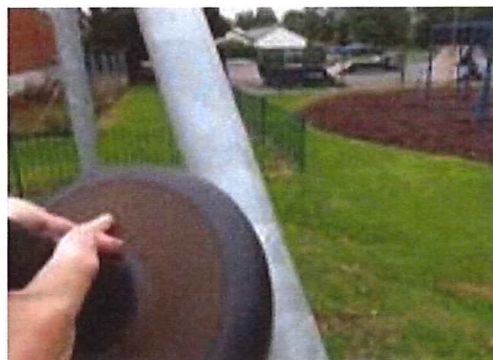
7. Aerial Runway

1 We recommend that the main cable is thoroughly inspected at least once every 2 years this; will involve either removing the cable or gaining access by ladders and/or steps to inspect for damage or internal rusting.

2 The nylon inserts are worn or missing at the point the cable enters the traveller

3 The height of the seat from ground level is less than 350mm when partially loaded

4 The seat is less than 2.0 metres from the post when extended at 45 degrees at the end of the area of travel

Risk Assessment: 2 x 4

Risk Assessment: 2 x 3

1 Inspect the cable as per the manufacturer's recommendations

2 Replace worn or missing inserts as required

3 Ensure the seat is a minimum of 350mm above ground level when loaded with 69.5kg

4 Adjust the cable stop position to ensure the minimum distance is maintained

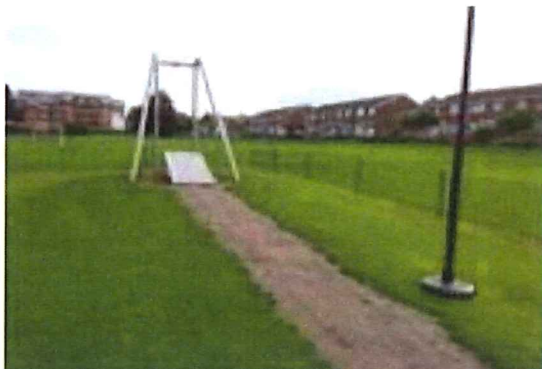
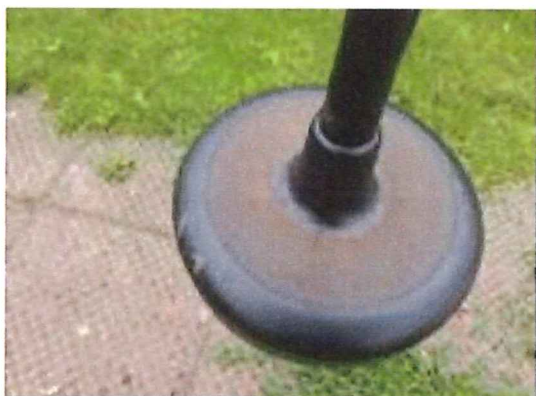
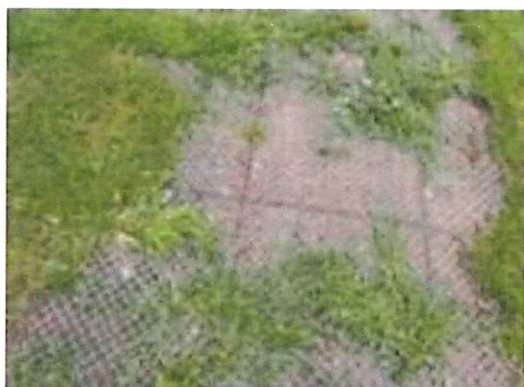
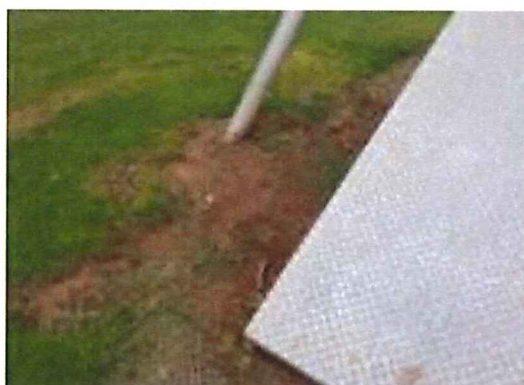
Aerial Runway continued/:-

- 5 The seat connection cannot be inspected without dismantling the seat
- 6 The traveller brake is not working
- 7 The grass mats are silted up, the soil
- 8 The surface has eroded around the item

Risk Assessment: 2 x 4

Risk Assessment: 2 x 3

- 5 Dismantle the seat to inspect the seat connection for wear

- 6 repair the traveller brake

- 7 Lift and relay the mats

- 8. Reinststate the surface

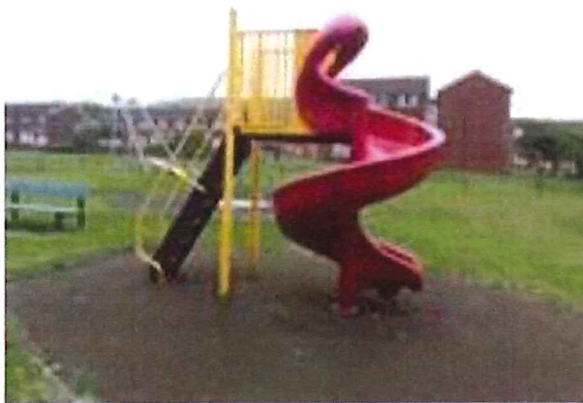
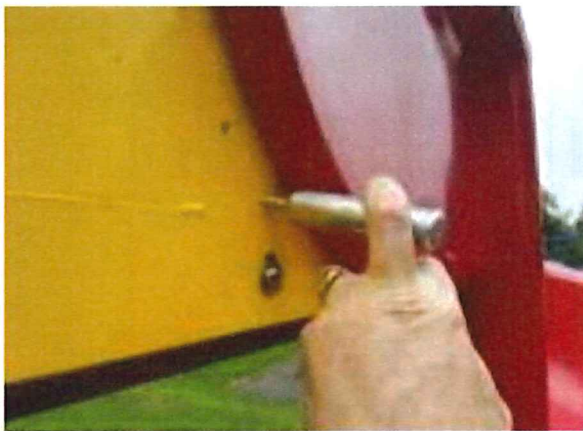
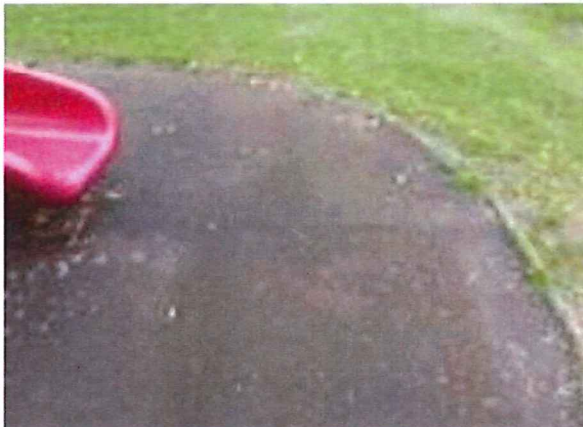
8. Helical Slide

1. There is/are finger entrapment(s) in the framework and the item fails to meet the requirements of BS EN 1176:2008 Part 1 4.2.7.6 Entrapment of Fingers.

2. The surfacing dimensions do not meet with the requirements of BS EN 1176 we consider this is a low risk finding.

Risk Assessment: 1 x 5

Risk Assessment: 2 x 3

1. Monitor use

2. Monitor use

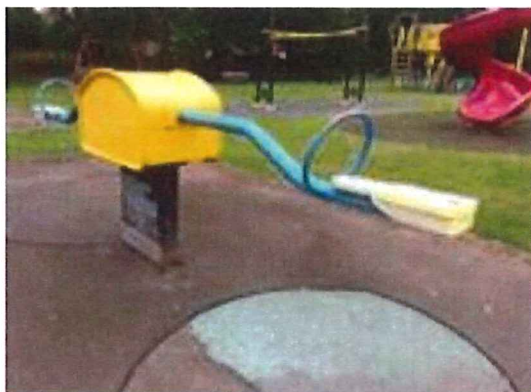
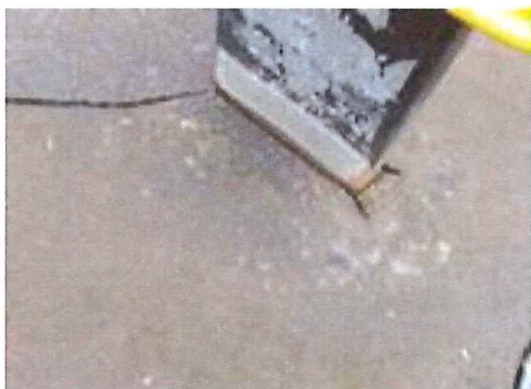
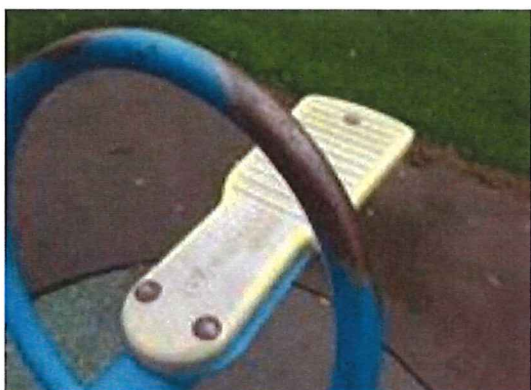
9. See Saw

1. The safety surfacing is damaged.
2. The paintwork on this item has been damaged or worn exposing the metal underneath.

Risk Assessment: 2 x 4

Risk Assessment: 2 x 3

1. Repair safety surface

2. treat and repaint the metalwork

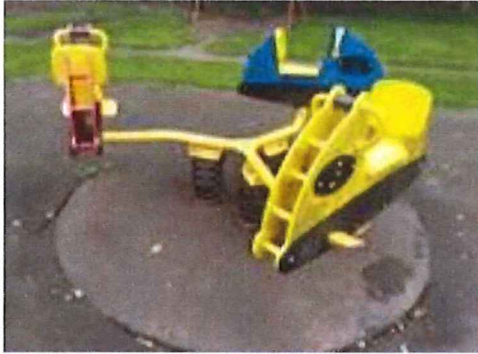
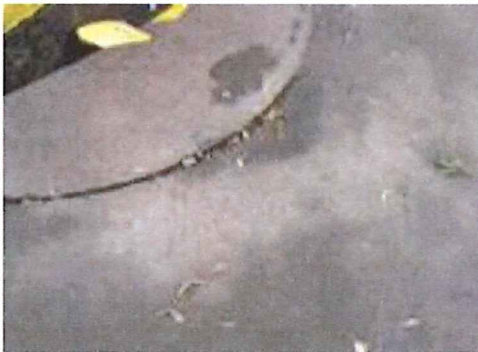
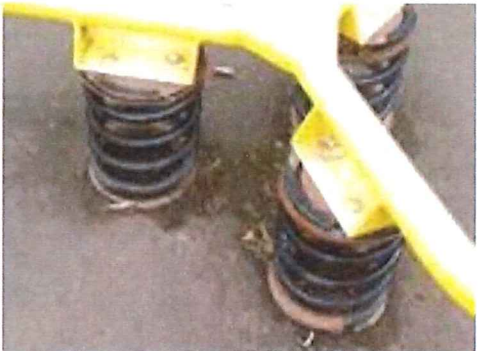
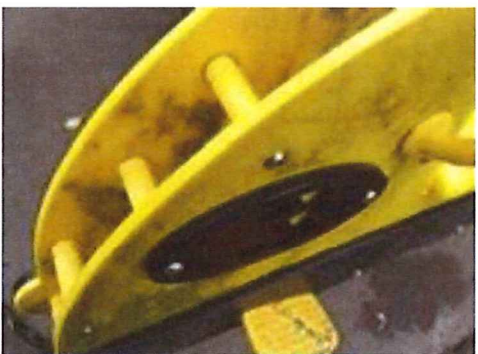
12. Three-way Springer

1. The safety surfacing is damaged
2. The paintwork on this item has been damaged or worn exposing the metal underneath which is rusting.
3. There is algae on this item.

Risk Assessment: 2 x 3

1. Monitor

2. Treat and repaint the metalwork

3. Remove algae and clean item
