RIDOUT ASSOCIATES

WASP INFESTATION AT THE MARKET HOUSE AND COUNCIL OFFICES, LEDBURY

1.0 INTRODUCTION

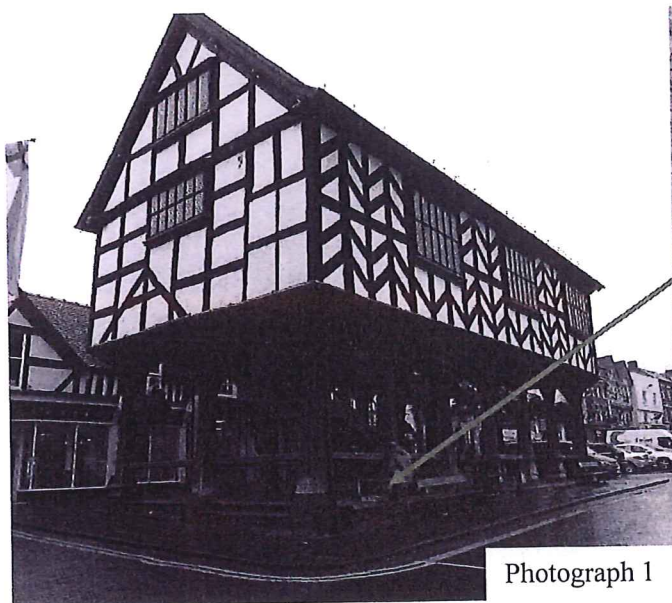
Photograph 1

Fine dust was found erupting from holes that were about 1cm in diameter in the following locations (photographs 1&2, 3&4).

The dust is discarded from the construction of the gallery and the wasp is not able to burrow into sound wood. These wasps are therefore living in decayed timber and not causing fresh damage.

Eradication would be difficult because the wasp galleries are probably deep in the timber. It is also likely that the population has colonised other buildings where post bases or sole plate undersides have partially decayed over the centuries. The localised application of a contact insecticide paste might control the problem if the insects become a nuisance.

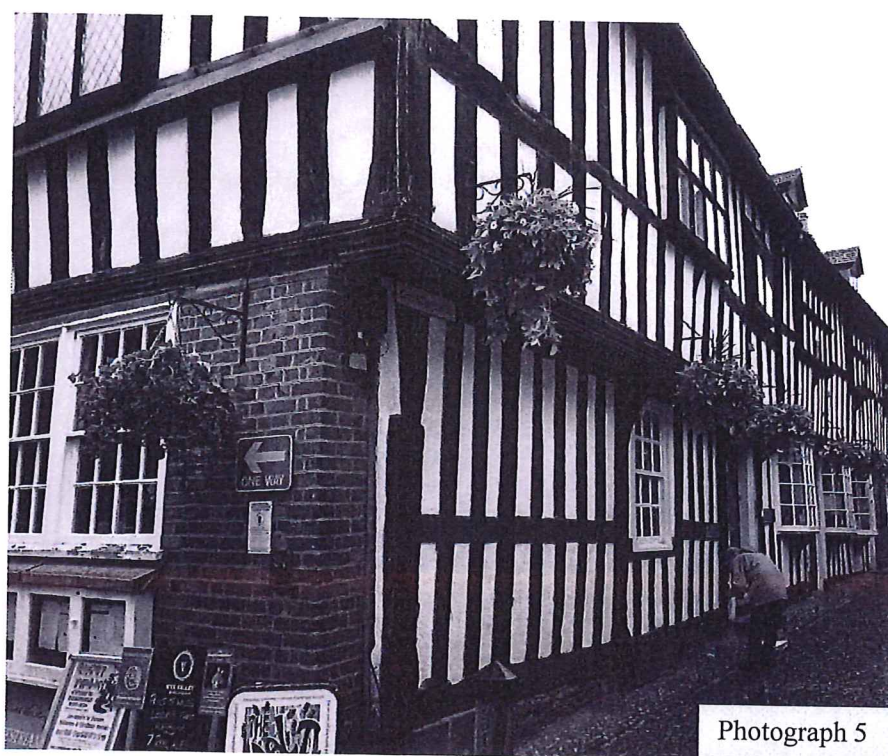
Photograph 5

Dust was similarly apparent along the length of the sole plate (photographs 5 & 6) of the Council Office. Microscopic examination of dust from both buildings showed that it was chewed fragments of decayed timber and not wood-boring insect frass.

This damage was caused by wasps. We managed to find some dead specimens in debris along the sole plate and found it to be *Ectemnius cavifrons* – a solitary crabronid wasp (photograph 7).

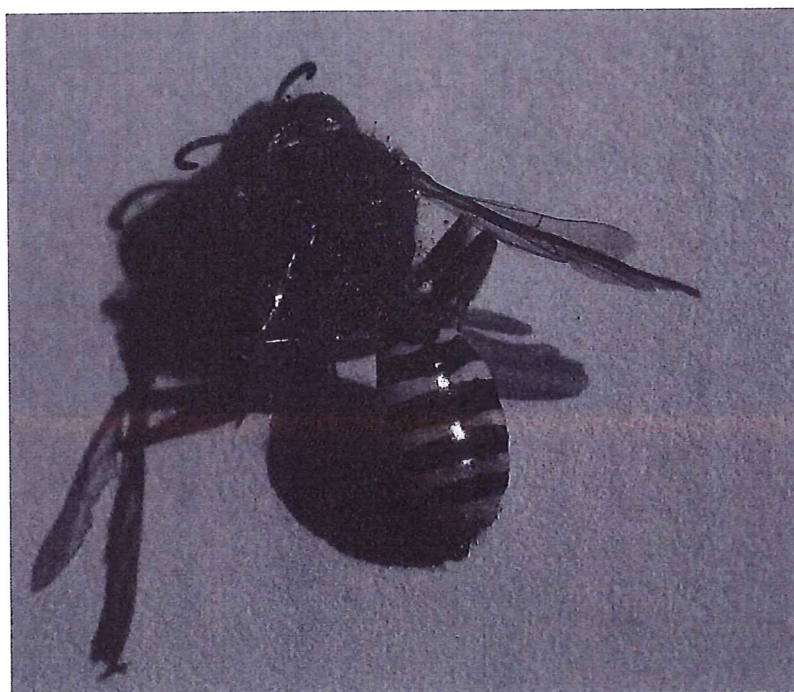
Ectemnius cavifrons makes nesting galleries in decayed wood where she forms perhaps 12 – 14 individual chambers each provisioned with about 6 paralysed flies. The wasps are active hunters during the day and may be very curious, but they are not aggressive like normal domestic wasps.
