# LEDBURY TOWN COUNCIL

## LEDBURY Town Council Offices

### Report on the Quinquennial Survey

## Report on the Quinquennial Survey for 2025

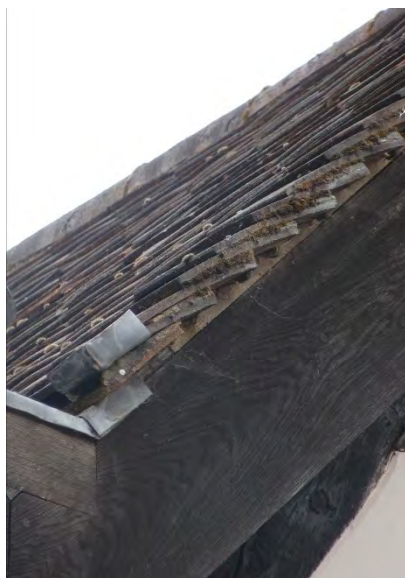
Fig 1.4  
Uneven eaves tiles to south at junction between historic buildings which make up the council offices.

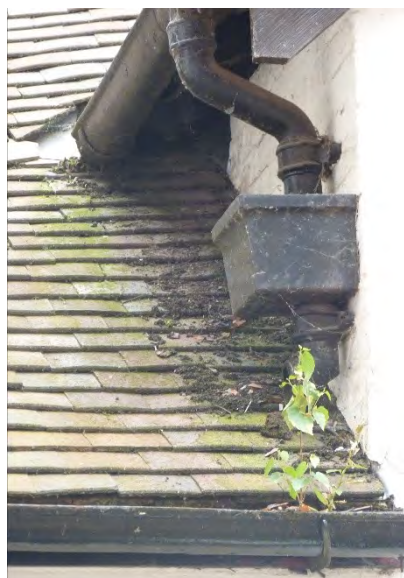
Fig 1.5  
Existing lead detailing to north elevation, redirecting rainwater away from roof carpentry.

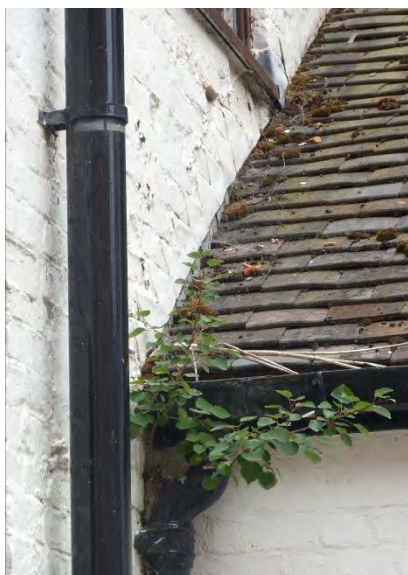
- 8.5 The rainwater shoe from the gable wall above the kitchen creates a weak point where rainwater overflows. This area should all be inspected, overhauled and cleared. Additional lead soakers might be considered beneath the rainwater shoe to help protect this area of localised high rainwater surcharge. Photograph 1.6

Fig 1.6  
Debris and vegetation to roof above kitchen, where roofs surcharge and there is a gutter backfall.

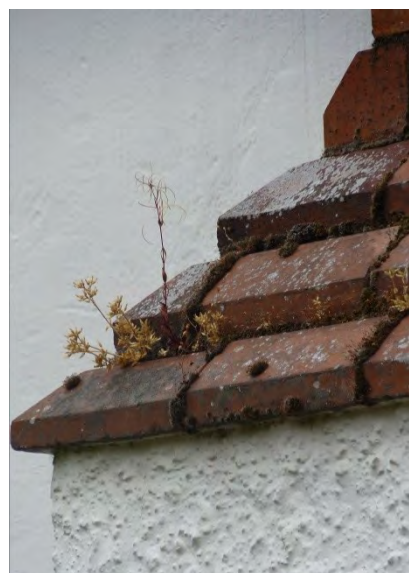
- 12.6 EASTERNMOST GROUND FLOOR OFFICE G11, LOBBY & TOILET G12
- 12.7 There are active leaks around the boarded soffit and ventilation grille which block the flue to the disused fireplace, which requires very prompt investigation. What might be a low arched iron plate supporting the front of the chimney breast is rusting slightly. Once leaks are cured, damaged finishes and linings should be removed and the area redecorated. The whole height of the chimney stack above should be investigated and leaks addressed as a matter of urgency. Photographs 2.3, 2.4, 8.3

Fig 2.3  
Gaps where rainwater enters at  
junction of head of lean-to roof  
with timber frame and render,  
south east corner.

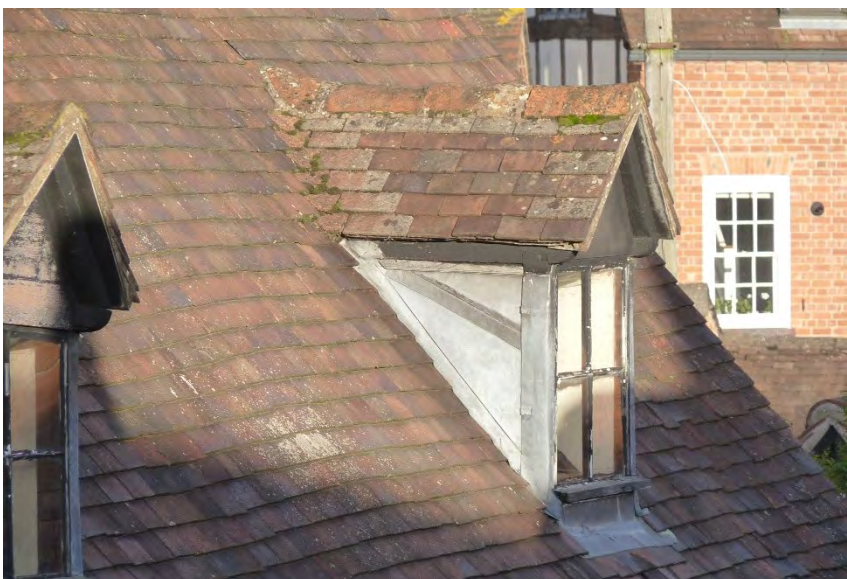
Fig 3.3 and 3.4  
Slipped clay plain tiles with moss build-up, windows and roof carpentry to south dormers in need of overhaul. Slipped apron flashings beneath dormer windows.

These photographs were taken two years ago from the Market House. Some repairs may already have taken place.

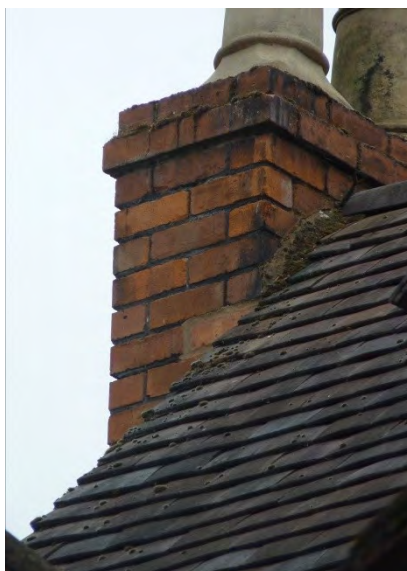
Fig 4.2  
North elevation of central stack. At least one friable brick. Moss grows on joints between slate capping and on brickwork.

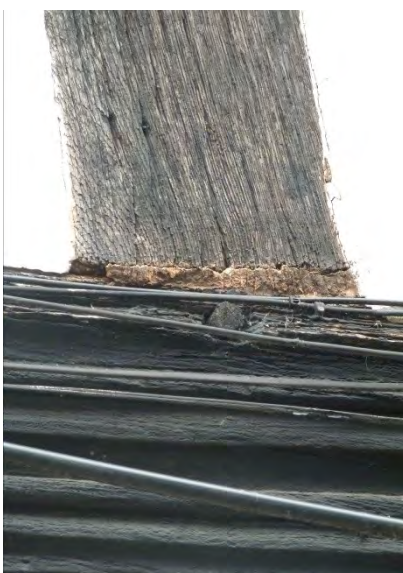
- 9.5 The cill beneath the westernmost south window should be checked where timbers are opening up. Improved detailing such as lead caps to the first-floor window cill horns should be considered. Photograph 5.3

Fig 5.3  
Gaps to timber frame beneath  
window cill, south elevation.

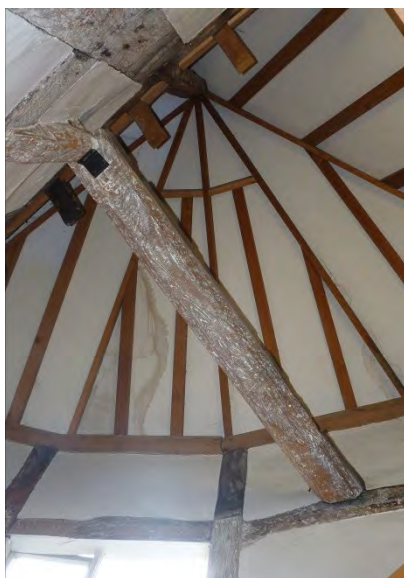
Fig 10.5  
Worsening dampness in ceiling and  
timber frame wall at junction of  
Painted Room stairwell with north  
west corner of main building.

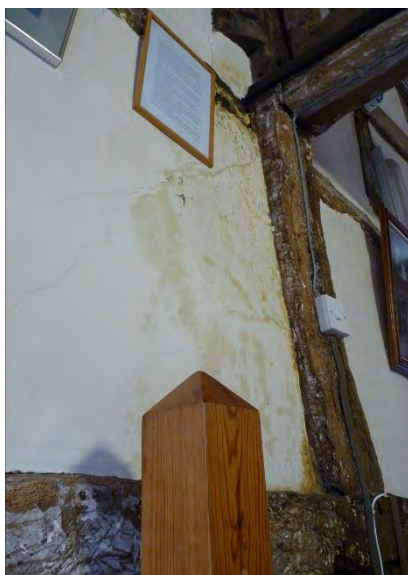
Fig 10.6  
Dampness in raking ceiling, as 10.5  
above.

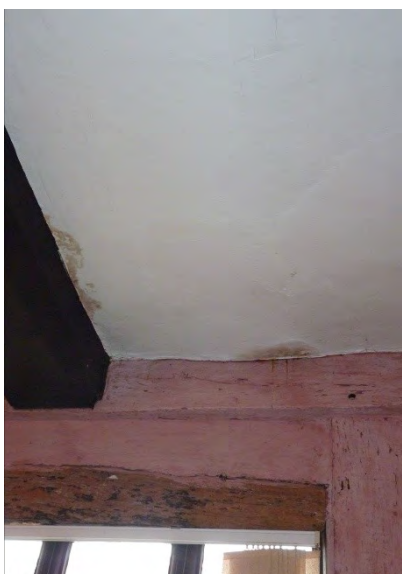
Fig 11.4  
Dampness in ceiling and north wall  
to Pink Room.

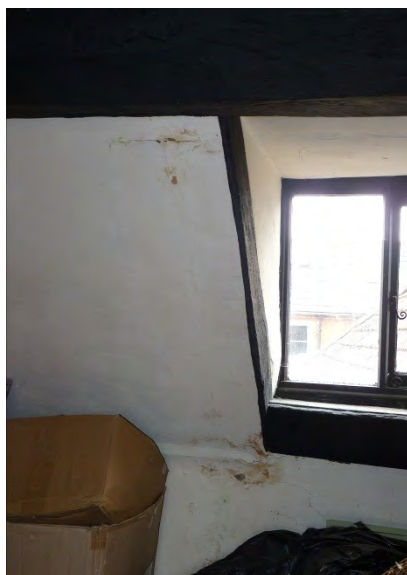
- 14.2 Putty around the fixed dormer window to the south is in poor condition. Daylight can be seen above at least the uppermost east pane and the upper and lower east panes. Repair is urgently needed. The central horizontal glazing beads to the west may have dropped slightly, all should be carefully inspected and repaired. Photograph 11.6

Fig 11.6  
Gaps between glass and frame to  
south attic window.

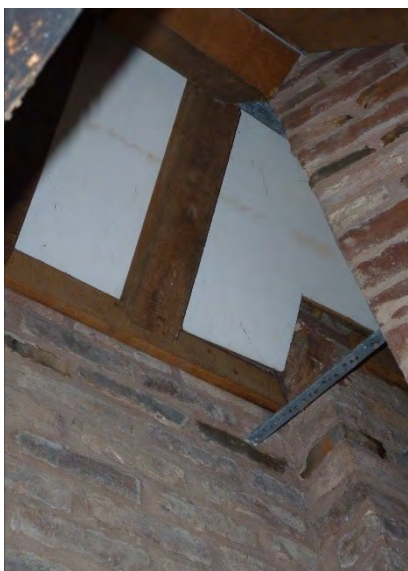
- 14.17 The western rooflight suffers condensation.
- 14.18 There is water staining beneath the timber frame to the west gable window, and in small areas close to the central stack, which should be monitored. Photographs 12.3, 12.4

Fig 12.3  
Small areas of dampness in attic  
adjacent to central stack.

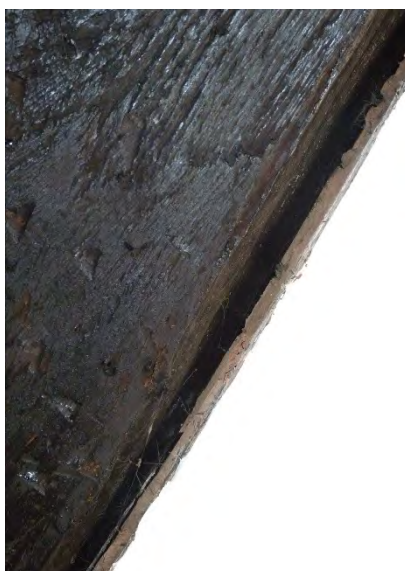
- 12.53 There is damp staining and probably active leaks between infill panels and the north facing timber frame, originating around the staircase window. There are leaks beneath the noticeboard. All should be carefully investigated during and after heavy rain, to identify water entry points. Repair should then follow. Water penetration is less than to the more westerly gables and walls but should ideally be repaired at the same time. Photographs 11.1, 11.2, 14.2

Fig 14.2  
Water penetration at high level  
inside north gable.

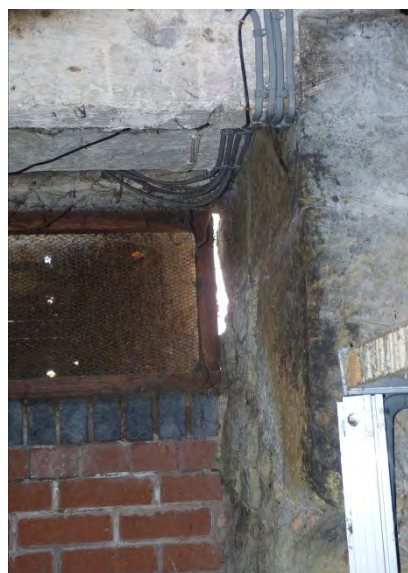
Fig 15.3  
Damp cellar walls at south west  
corner beneath timber frames and  
floor beams.
