LEDBURY TOWN COUNCIL OFFICES

Report on the Quinquennial Survey

Revision A - September 2018

Listed Grade II*

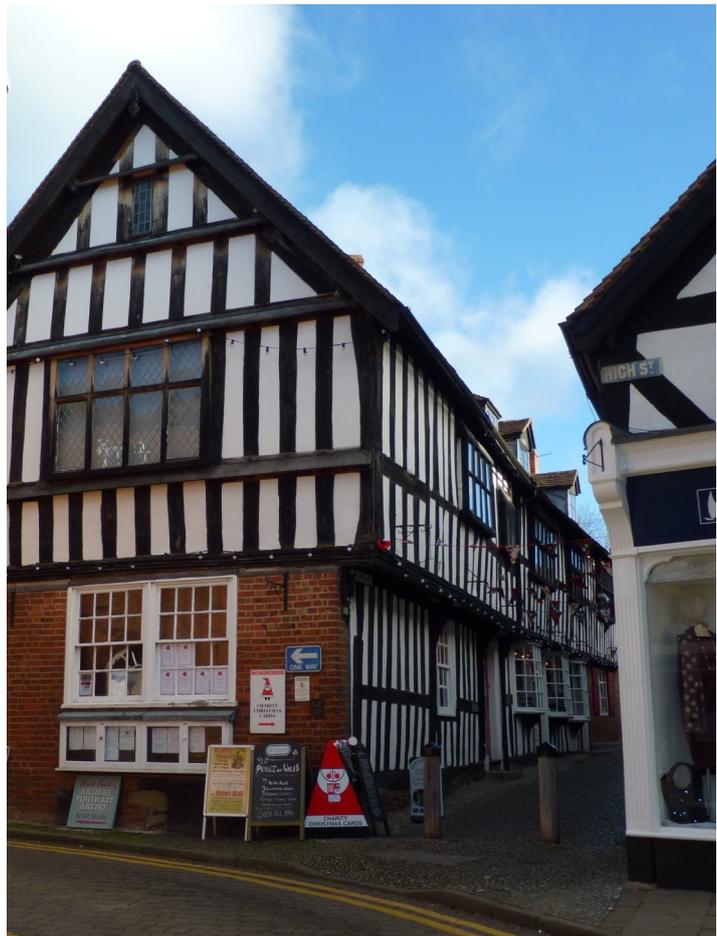
Range of timber framed buildings located on Church Lane in central Ledbury, combined to provide accommodation for the Town Council. The earliest part is fifteenth century, with sixteenth century and eighteenth century additions and alterations. Timber frame walls with render infill panels and some brickwork at low level, clay tile roof coverings, mixture of timber sash and leaded light windows
